**APPENDIX B:  
SEGMENT, CREEK & WETLAND ASSESSMENTS**

# SEGMENT ASSESSMENTS

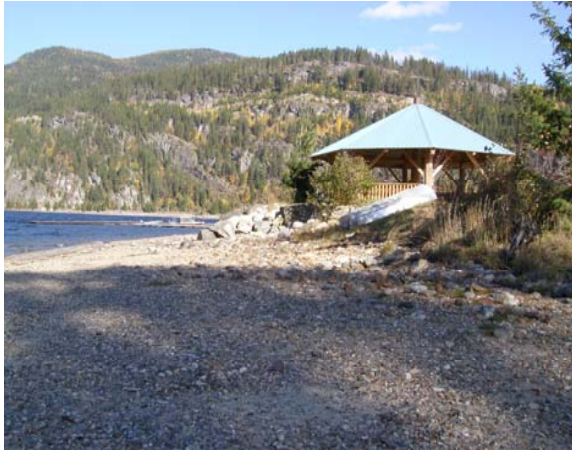
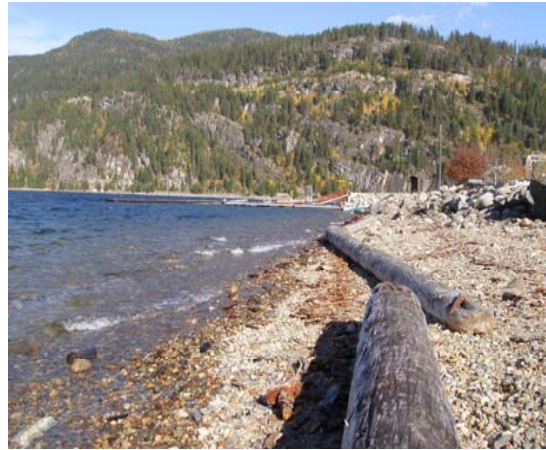
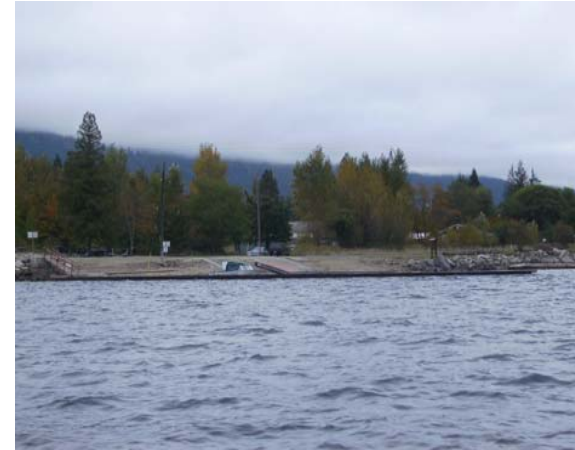
## Slocan Lake: Segment 1

Segment Length (m)	Shore Type	Shore Type Modification	Slope	Land Use	Level of Impact	Disturbed	Natural	Class Comment
521	Stream	Dock, Retaining Wall	Low	Park	High	90%	10%	Slocan River

Although located in a highly developed area, the Slocan Lake outlet (Segment 1) offers excellent spawning grounds within the margins of the lake outflow. The site has long outwash gravel bars with half-embedded boulders. During the survey, most fish observed were within the tailout of the lake outlet. Fish species of all stages were observed using the area, including schools of YOY and juvenile fish.

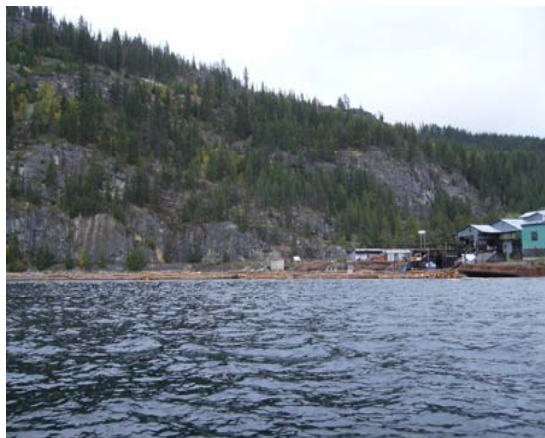
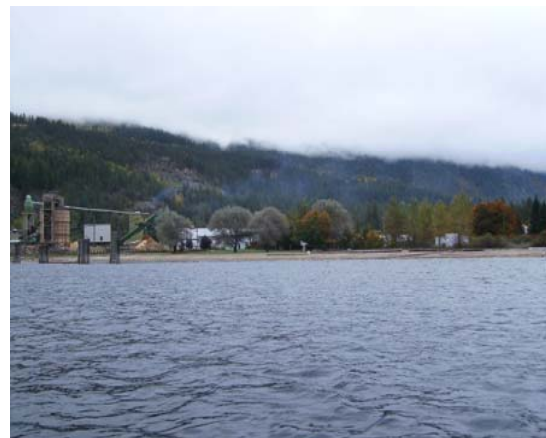
## Slocan Lake: Segment 2

Segment Length (m)	Shore Type	Shore Type Modification	Slope	Land Use	Level of Impact	Disturbed	Natural	Class Comment
302	Gravel	Dock, Retaining Wall	Low	Industrial	High	100%	0%

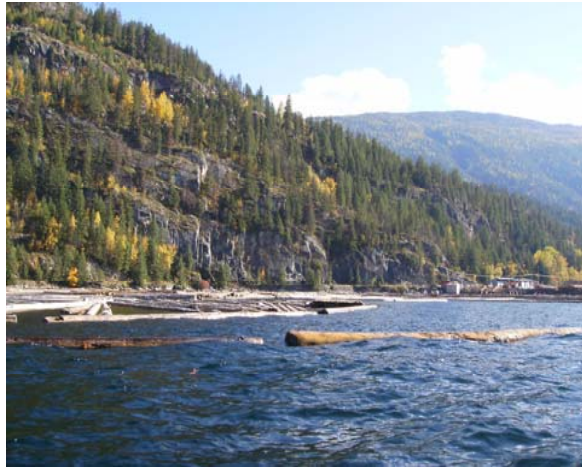
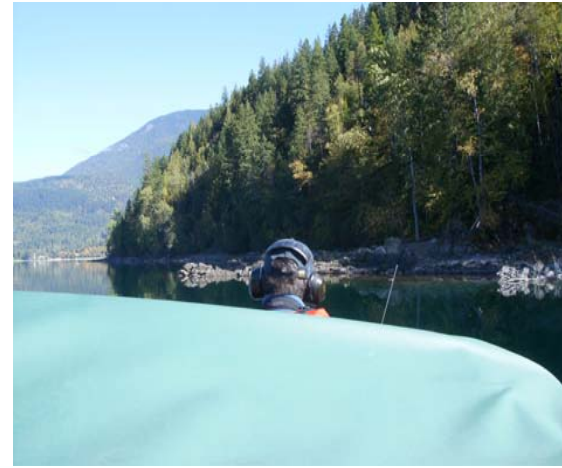
### Slocan Lake: Segment 3

Segment Length (m)	Shore Type	Shore Type Modification	Slope	Land Use	Level of Impact	Disturbed	Natural	Class Comment
589	Cliff/Bluff	Retaining Wall, Trail	Very Steep	Natural	Medium	40%	60%

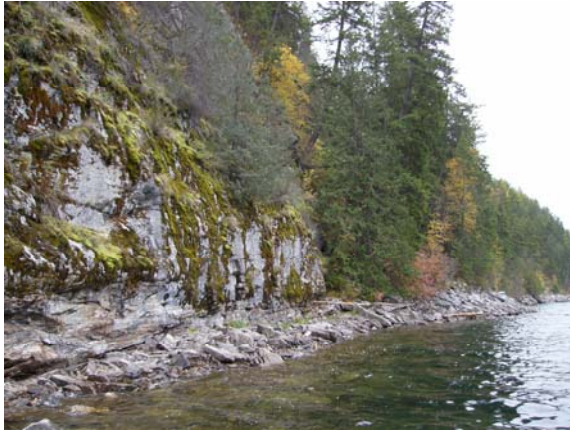
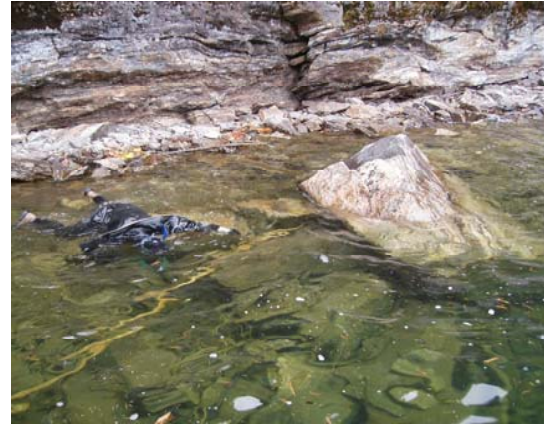
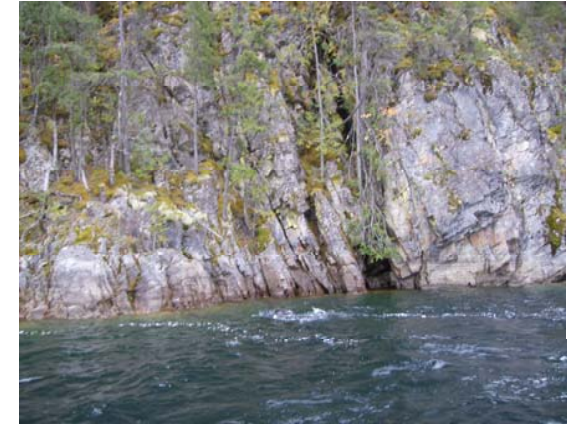
## Slocan Lake: Segment 4

Segment Length (m)	Shore Type	Shore Type Modification	Slope	Land Use	Level of Impact	Disturbed	Natural	Class Comment
749	Cliff/Bluff	None	Very Steep	Natural	None	0%	100%

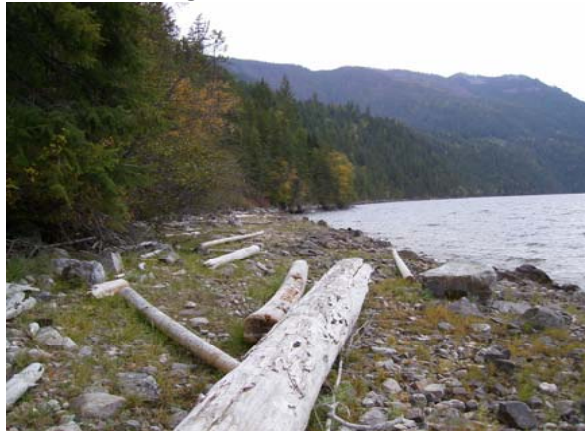
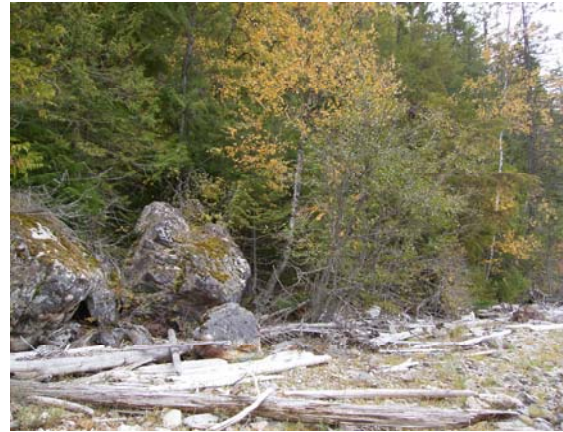
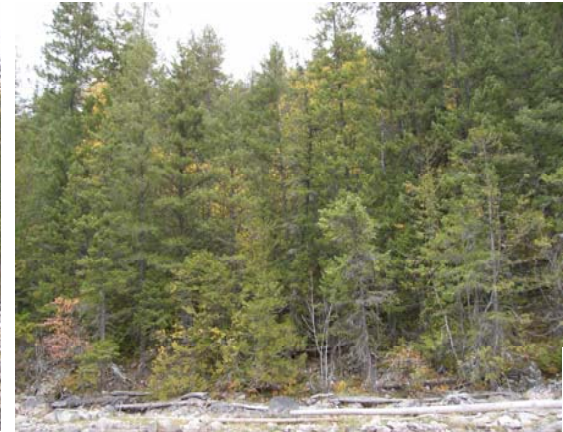
**Slocan Lake: Segment 5**

Segment Length (m)	Shore Type	Shore Type Modification	Slope	Land Use	Level of Impact	Disturbed	Natural	Class Comment
1521	Rock	None	Steep	Natural	Low	1%	99%

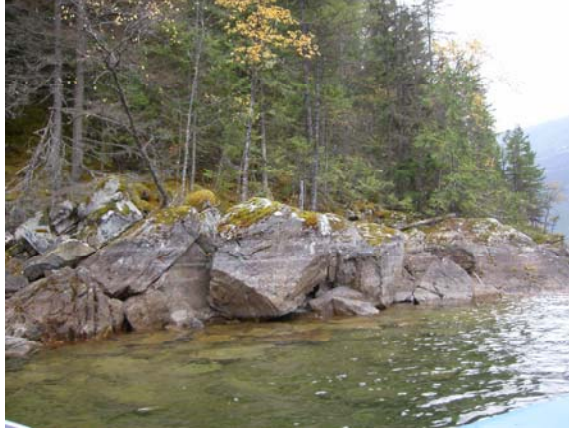
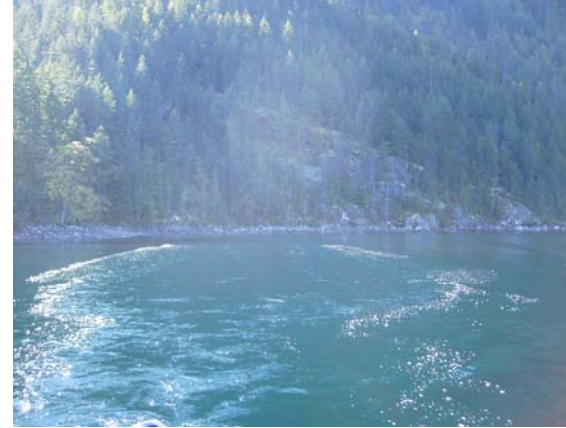
**Slocan Lake: Segment 6**

Segment Length (m)	Shore Type	Shore Type Modification	Slope	Land Use	Level of Impact	Disturbed	Natural	Class Comment
5905	Cliff/Bluff	None	Very Steep	Natural	None	0%	100%

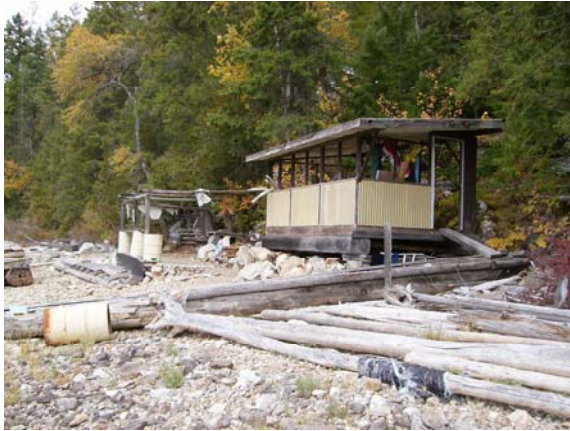
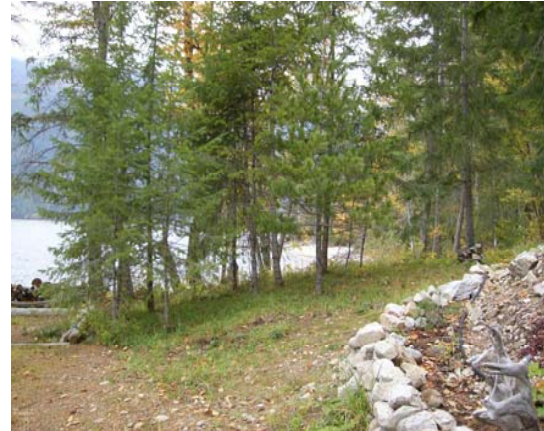
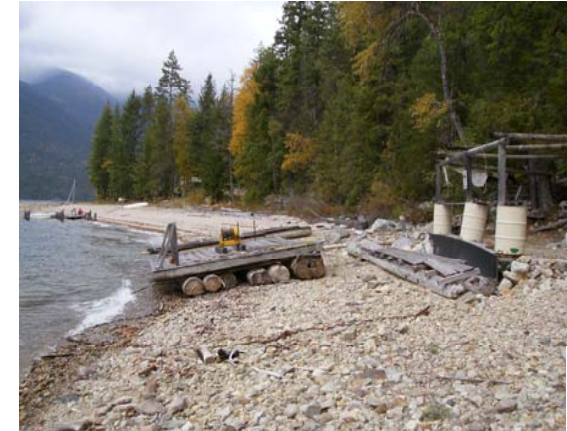
## Slocan Lake: Segment 7

Segment Length (m)	Shore Type	Shore Type Modification	Slope	Land Use	Level of Impact	Disturbed	Natural	Class Comment
406	Rock	Dock, Groyne	Low	Single Family	Medium	40%	60%

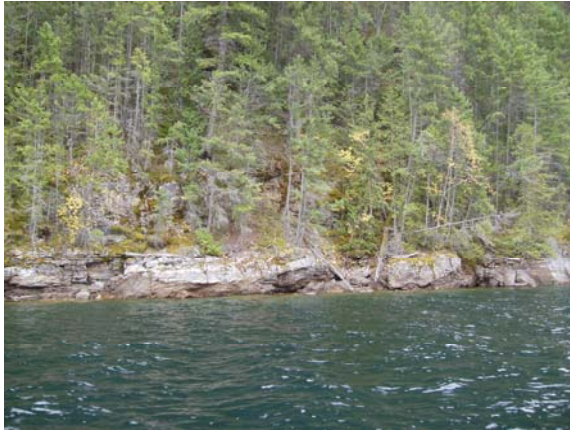
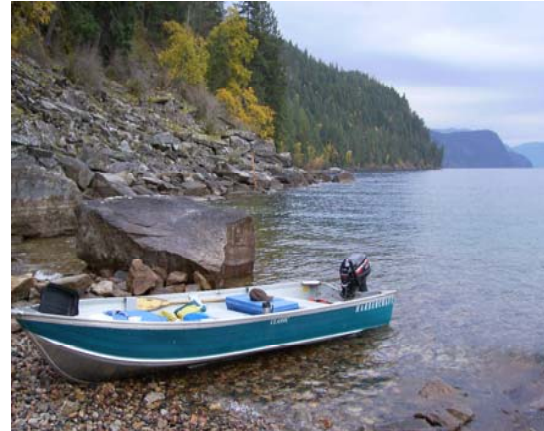
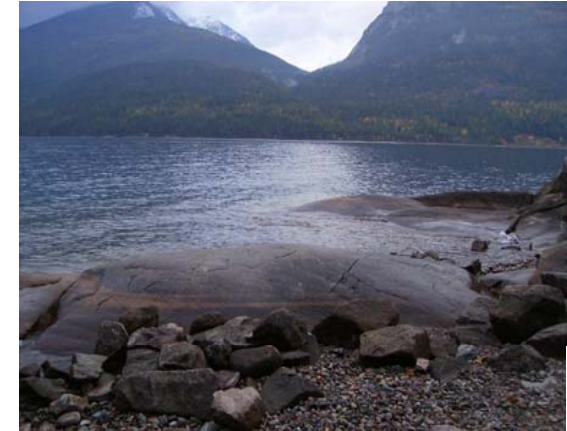
**Slocan Lake: Segment 8**

Segment Length (m)	Shore Type	Shore Type Modification	Slope	Land Use	Level of Impact	Disturbed	Natural	Class Comment
10785	Cliff/Bluff	Dock	Very Steep	Natural	None	0%	100%	Enterprise Creek

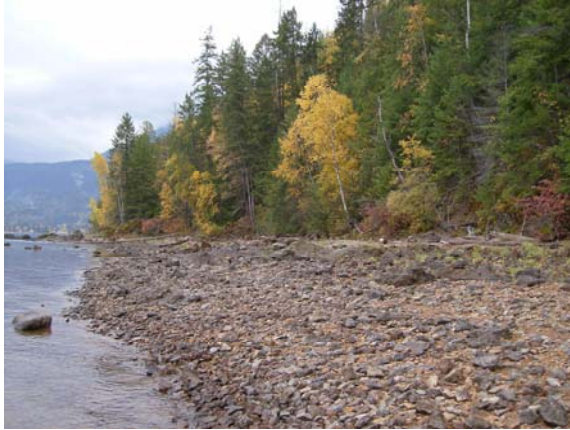
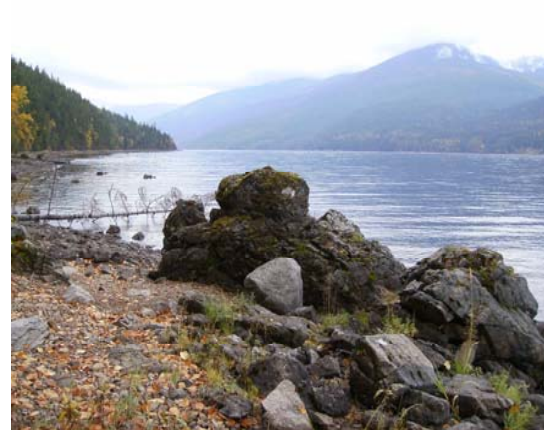
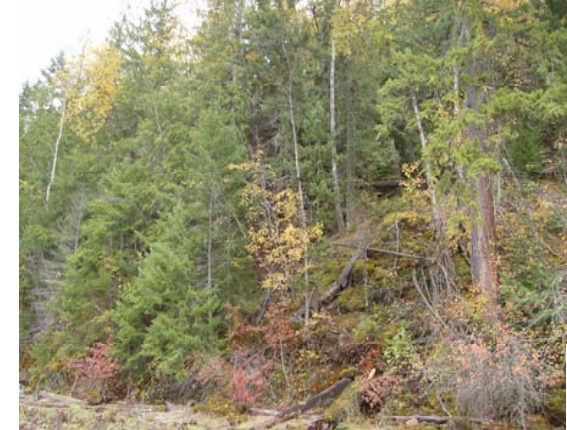
**Slocan Lake: Segment 9**

Segment Length (m)	Shore Type	Shore Type Modification	Slope	Land Use	Level of Impact	Disturbed	Natural	Class Comment
3050	Rock	None	Low	Natural	Low	1%	99%

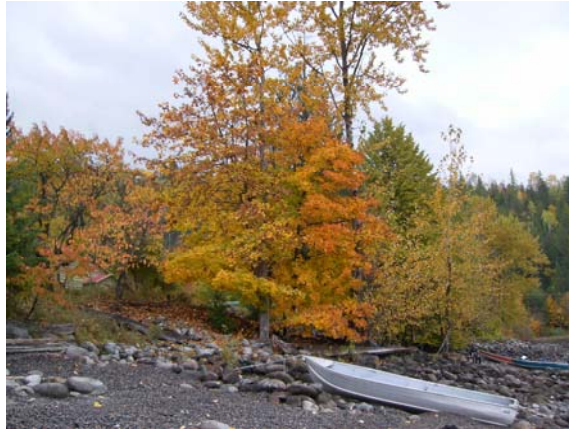
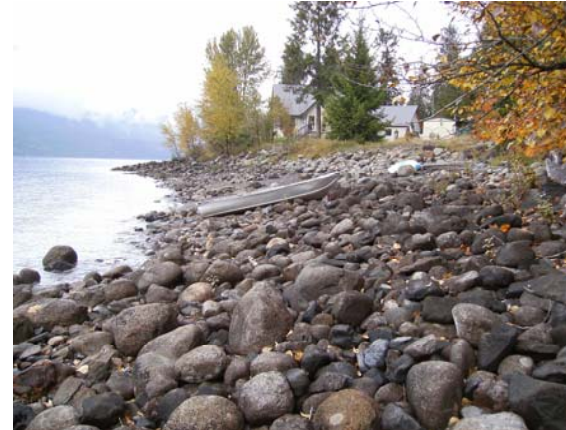
**Slocan Lake: Segment 10**

Segment Length (m)	Shore Type	Shore Type Modification	Slope	Land Use	Level of Impact	Disturbed	Natural	Class Comment
1699	Gravel	Retaining Wall, Dock,	Moderate	Single Family	High	100%	0%	Silverton Creek

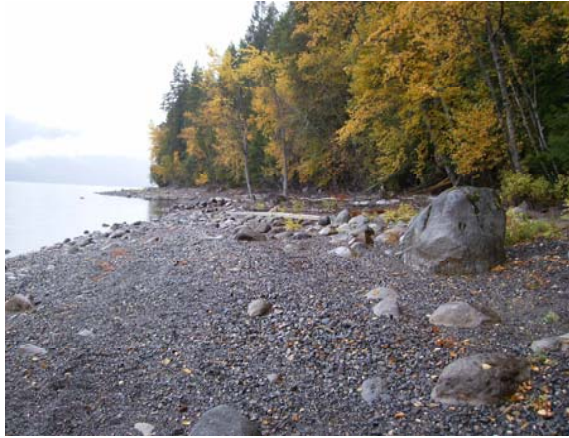
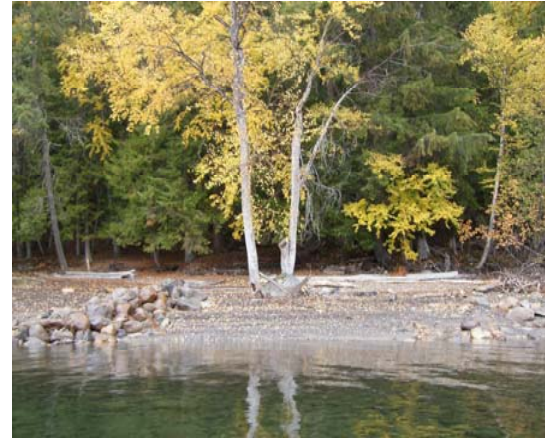
## Slocan Lake: Segment 11

Segment Length (m)	Shore Type	Shore Type Modification	Slope	Land Use	Level of Impact	Disturbed	Natural	Class Comment
3161	Gravel	Dock, Groyne	Low	Natural	Medium	10%	90%

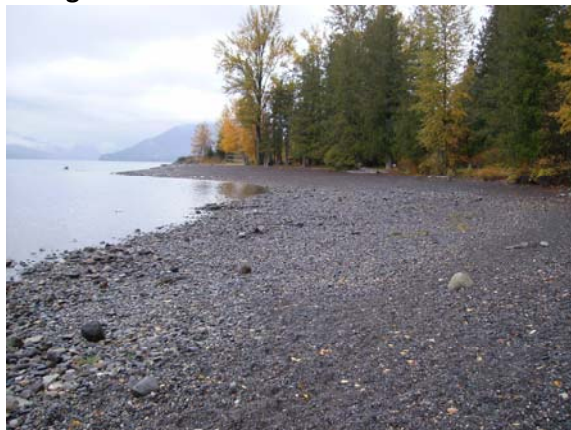
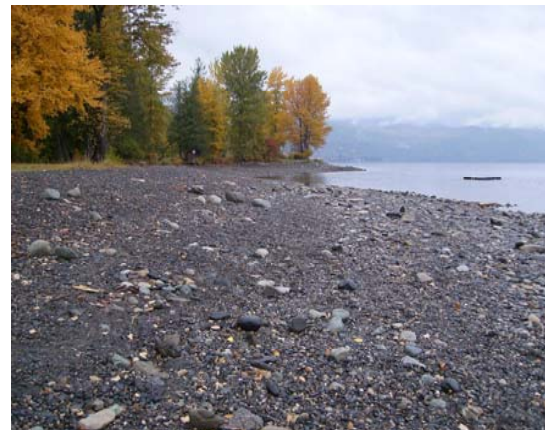
## Slocan Lake: Segment 12

Segment Length (m)	Shore Type	Shore Type Modification	Slope	Land Use	Level of Impact	Disturbed	Natural	Class Comment
2519	Rock	Retaining Wall, Dock,	Low	Single Family	High	70%	30%	Carpenter Creek

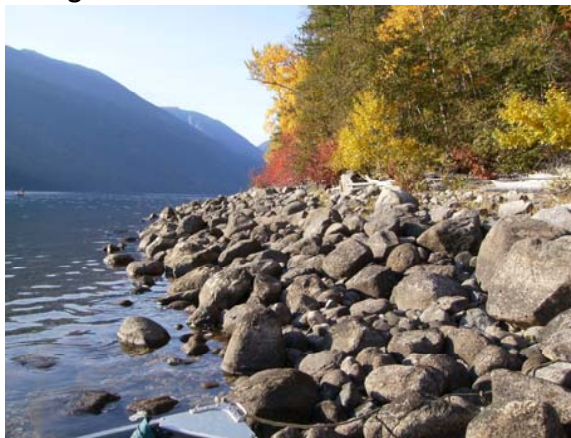
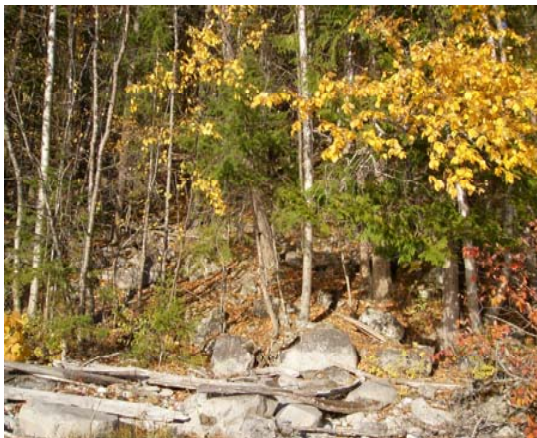
### Slocan Lake: Segment 13

Segment Length (m)	Shore Type	Shore Type Modification	Slope	Land Use	Level of Impact	Disturbed	Natural	Class Comment
4522	Rock	Retaining Wall, Trail	Low	Natural	Low	1%	99%

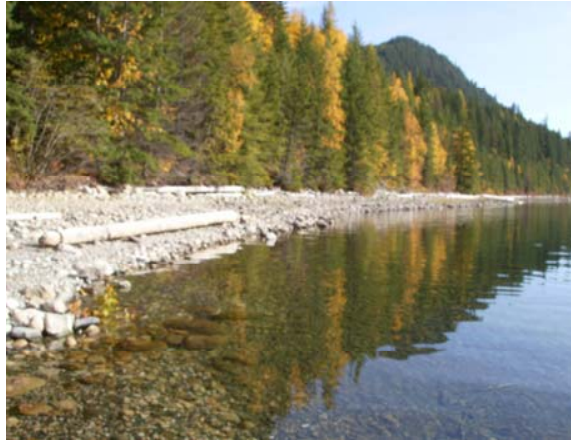
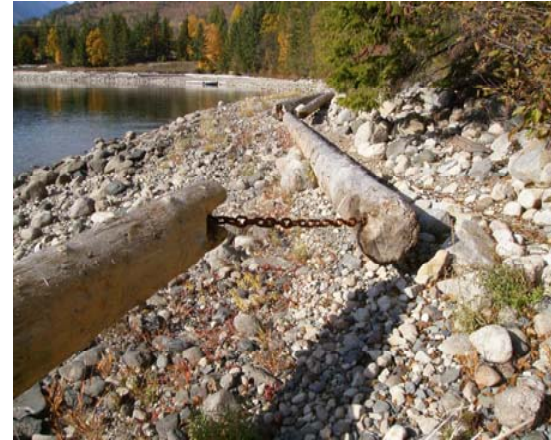
**Slocan Lake: Segment 14**

Segment Length (m)	Shore Type	Shore Type Modification	Slope	Land Use	Level of Impact	Disturbed	Natural	Class Comment
239	Gravel	None	Low	Industrial	High	90%	10%

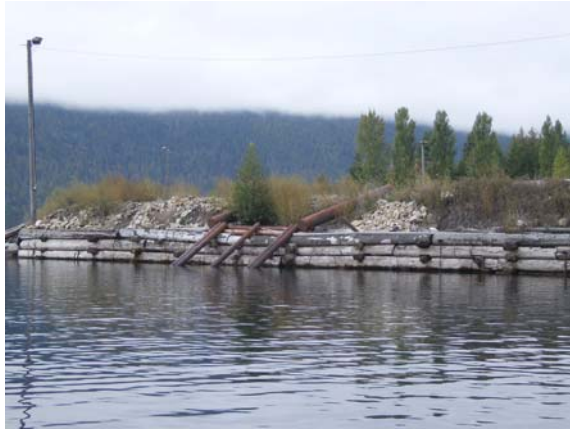
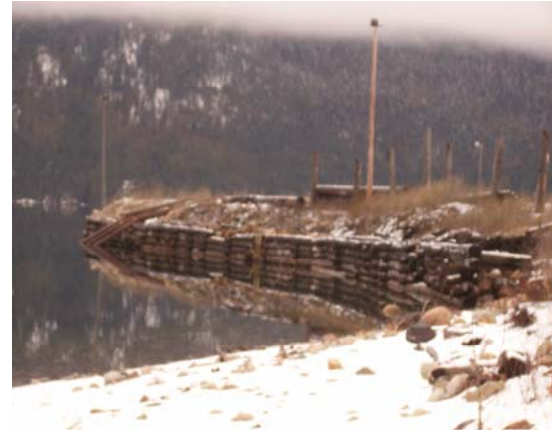
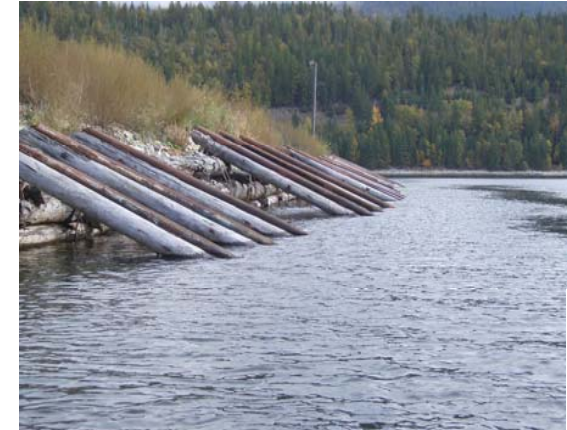
## Slocan Lake: Segment 15

Segment Length (m)	Shore Type	Shore Type Modification	Slope	Land Use	Level of Impact	Disturbed	Natural	Class Comment
246	Gravel	Retaining Wall	Low	Industrial	High	100%	0%

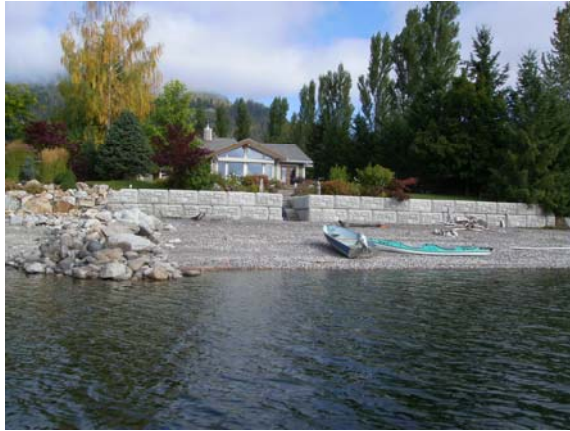
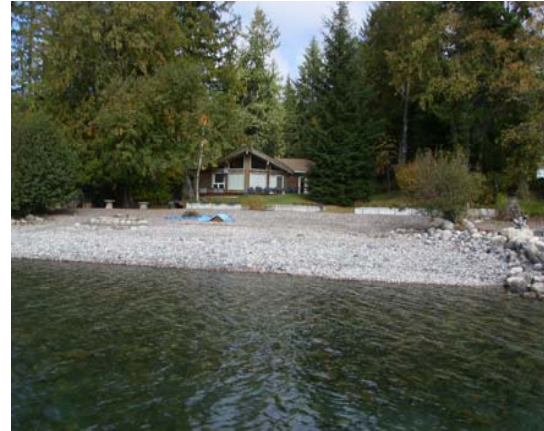
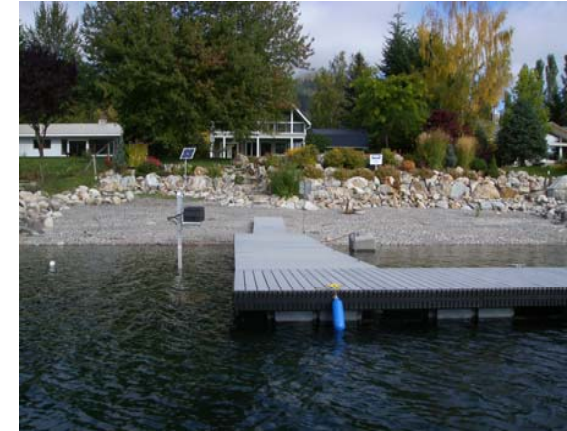
**Slocan Lake: Segment 16**

Segment Length (m)	Shore Type	Shore Type Modification	Slope	Land Use	Level of Impact	Disturbed	Natural	Class Comment
721	Gravel	Retaining Wall, Dock,	Low	Single Family	High	100%	0%

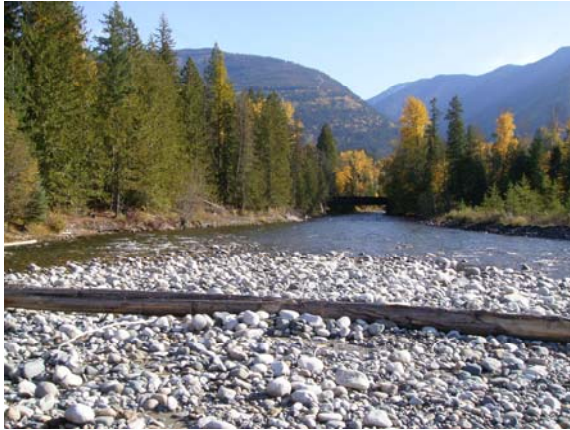
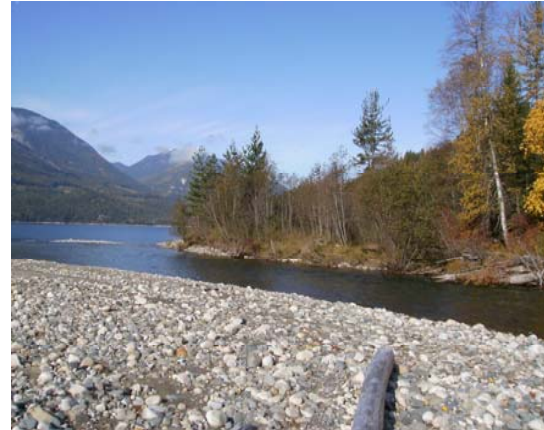
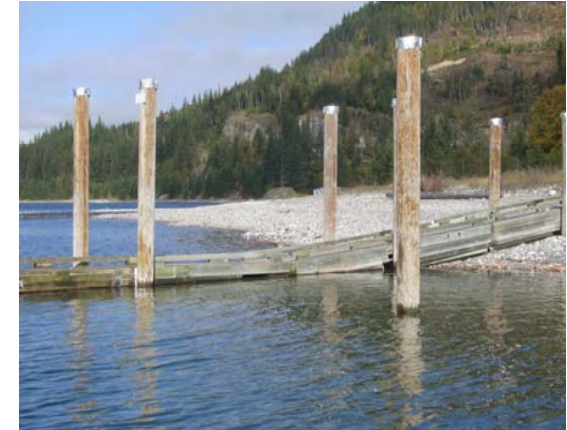
### Slocan Lake: Segment 17

Segment Length (m)	Shore Type	Shore Type Modification	Slope	Land Use	Level of Impact	Disturbed	Natural	Class Comment
522	Stream	Dock	Low	Park	None	0%	100%	Wilson Creek

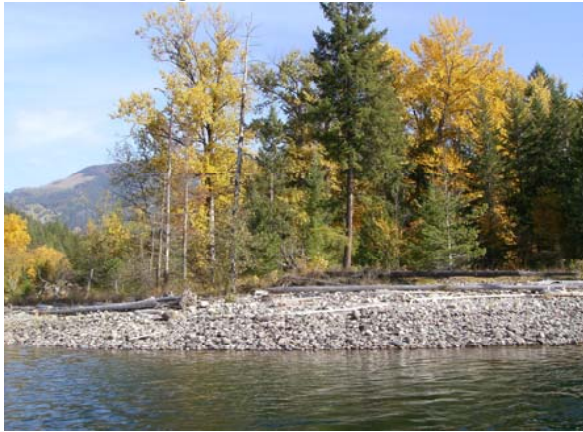
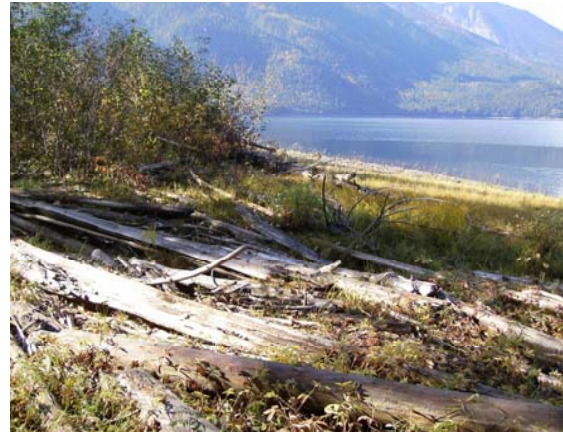
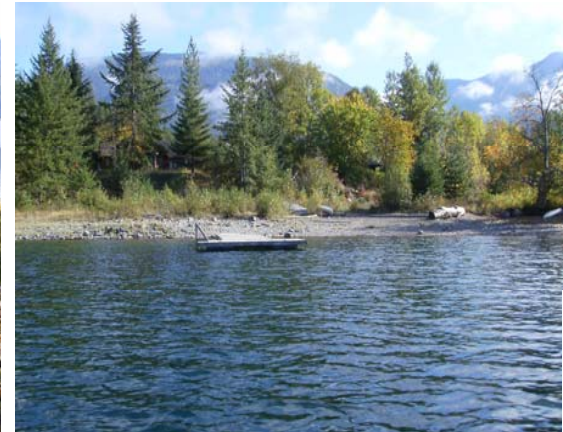
**Slocan Lake: Segment 18**

Segment Length (m)	Shore Type	Shore Type Modification	Slope	Land Use	Level of Impact	Disturbed	Natural	Class Comment
316	Gravel	Retaining Wall, Dock, Trail	Moderate	Park	High	70%	30%

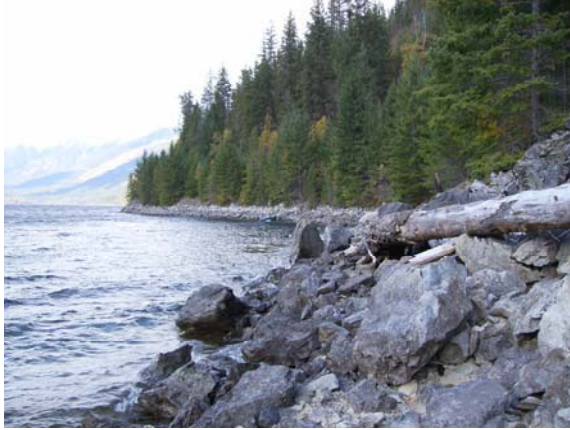
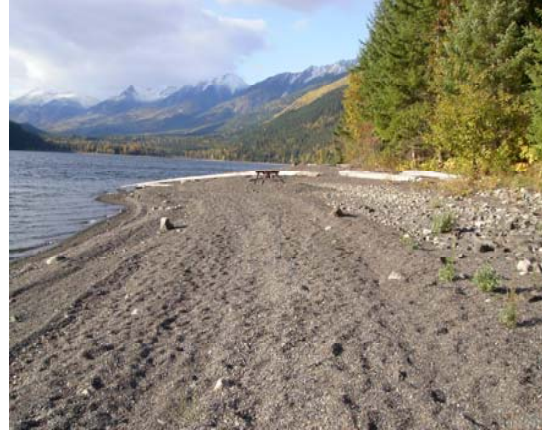
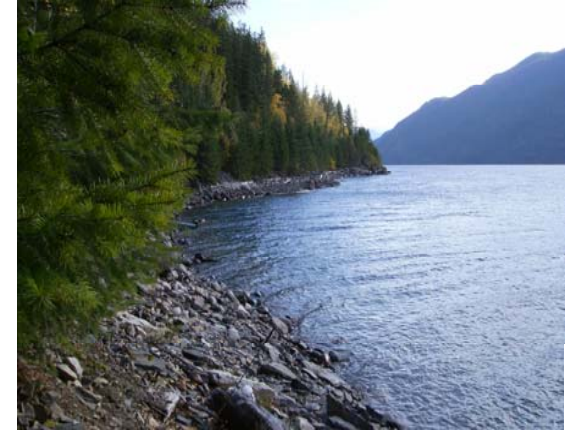
## Slocan Lake: Segment 19

Segment Length (m)	Shore Type	Shore Type Modification	Slope	Land Use	Level of Impact	Disturbed	Natural	Class Comment
7317	Rock	Retaining Wall, Trail	Moderate	Natural	None	0%	100%

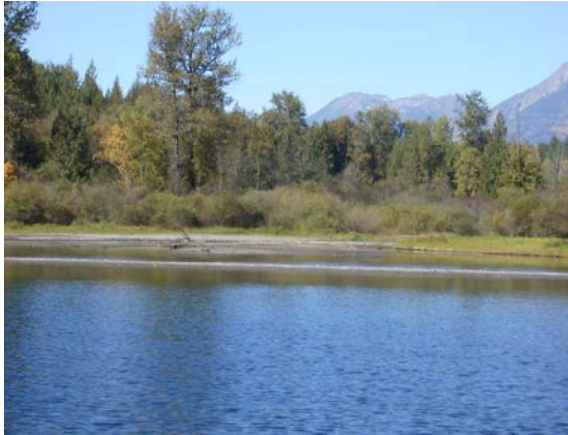
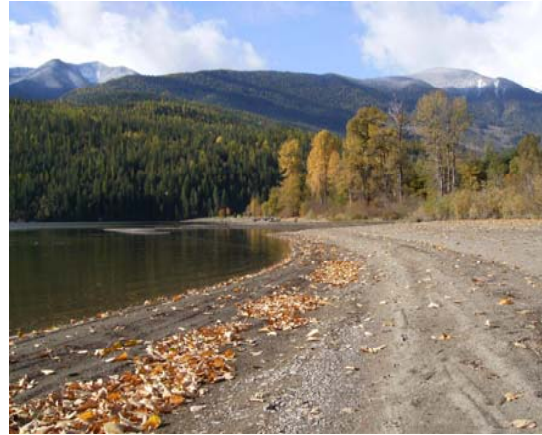
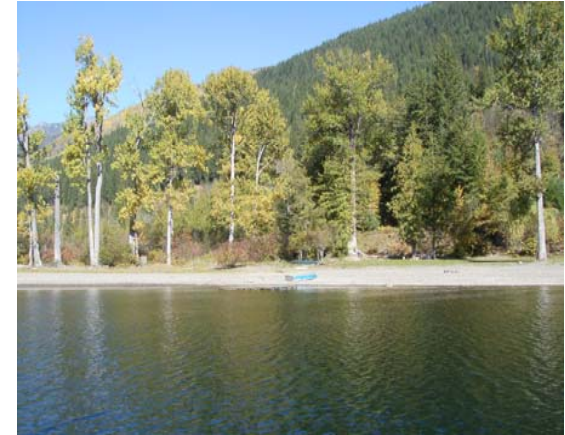
## Slocan Lake: Segment 20

Segment Length (m)	Shore Type	Shore Type Modification	Slope	Land Use	Level of Impact	Disturbed	Natural	Class Comment
873	Stream	Trail	Low	Natural	Low	5%	95%	Bonanza Creek

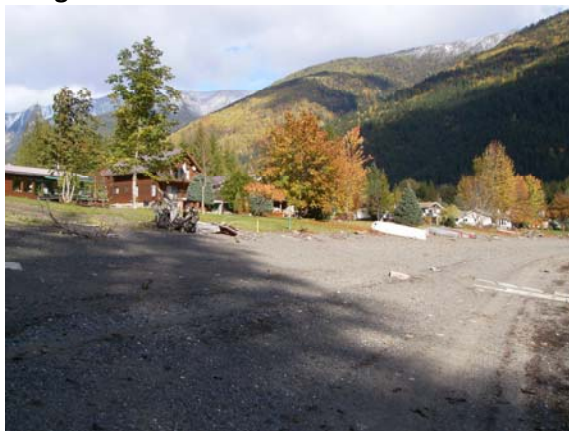
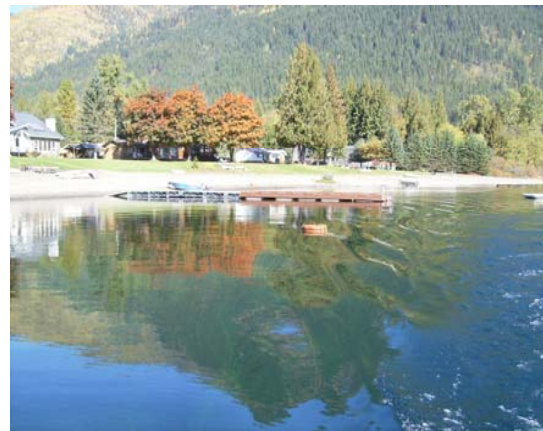
## Slocan Lake: Segment 21

Segment Length (m)	Shore Type	Shore Type Modification	Slope	Land Use	Level of Impact	Disturbed	Natural	Class Comment
493	Sand	Retaining Wall, Dock	Moderate	Single Family	High	100%	0%

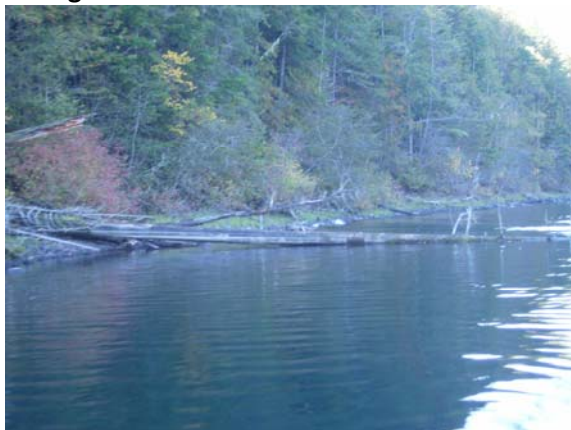
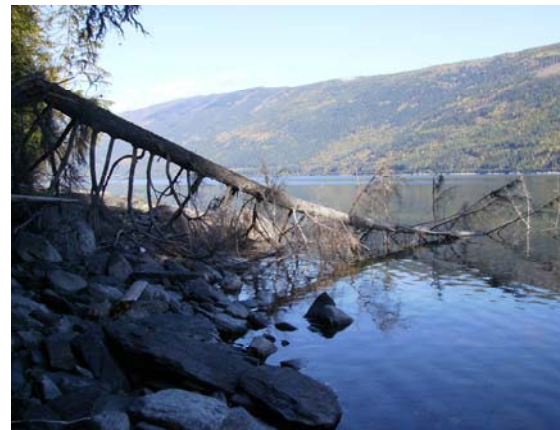
## Slocan Lake: Segment 22

Segment Length (m)	Shore Type	Shore Type Modification	Slope	Land Use	Level of Impact	Disturbed	Natural	Class Comment
3426	Rock	Retaining Wall, Dock,	Steep	Natural	None	0%	100%

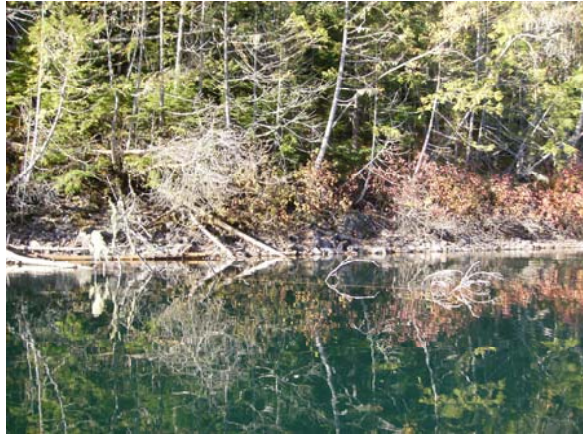
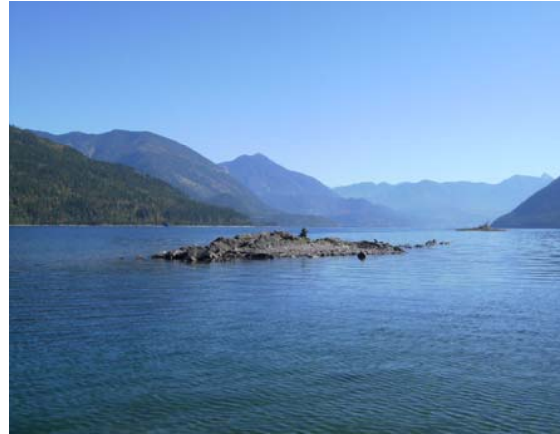
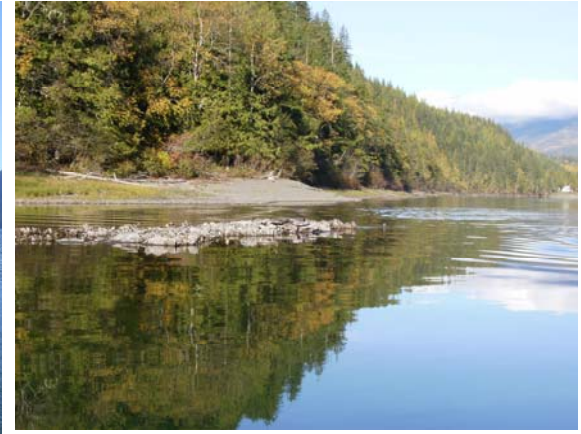
**Slocan Lake: Segment 23**

Segment Length (m)	Shore Type	Shore Type Modification	Slope	Land Use	Level of Impact	Disturbed	Natural	Class Comment
2216	Gravel	Dock	Moderate	Natural	None	0%	100%	Shannon Creek

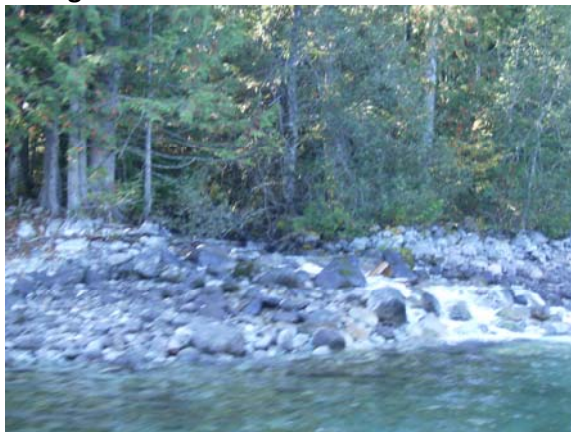
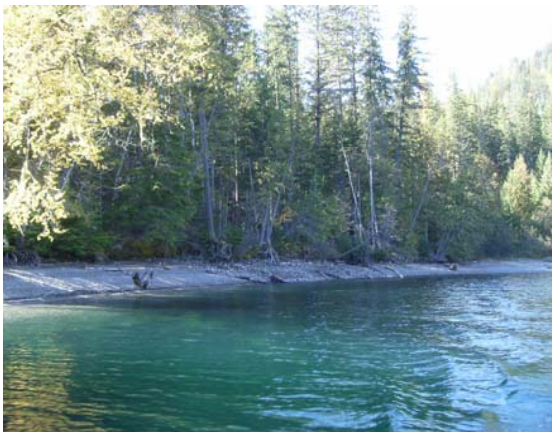
## Slocan Lake: Segment 24

Segment Length (m)	Shore Type	Shore Type Modification	Slope	Land Use	Level of Impact	Disturbed	Natural	Class Comment
4327	Rock	Dock	Steep	Natural	None	0%	100%

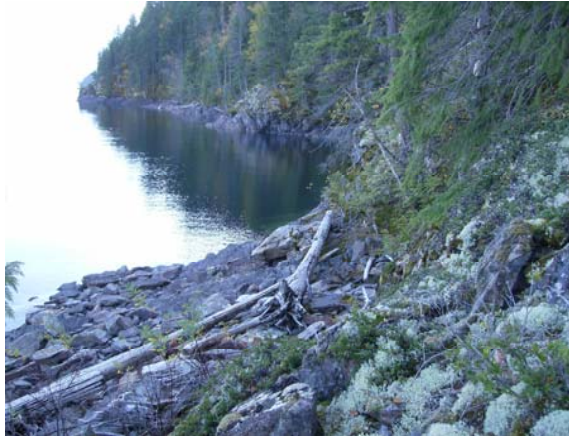
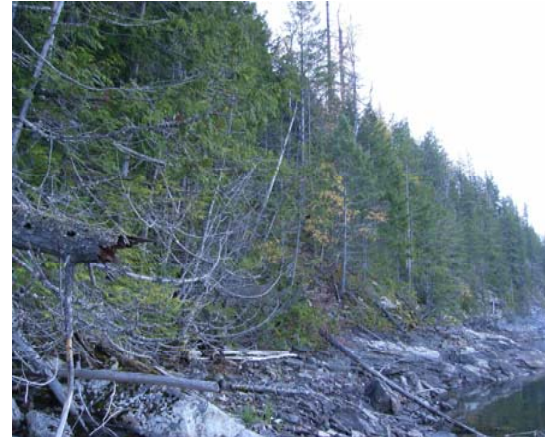
**Slocan Lake: Segment 25**

Segment Length (m)	Shore Type	Shore Type Modification	Slope	Land Use	Level of Impact	Disturbed	Natural	Class Comment
1256	Cliff/Bluff	None	Steep	Natural	None	0%	100%	Wragge Creek

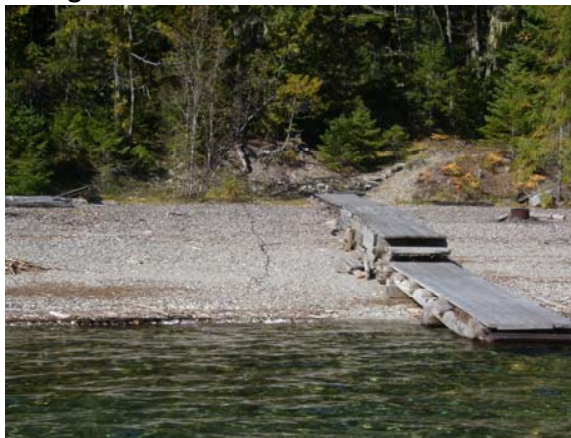
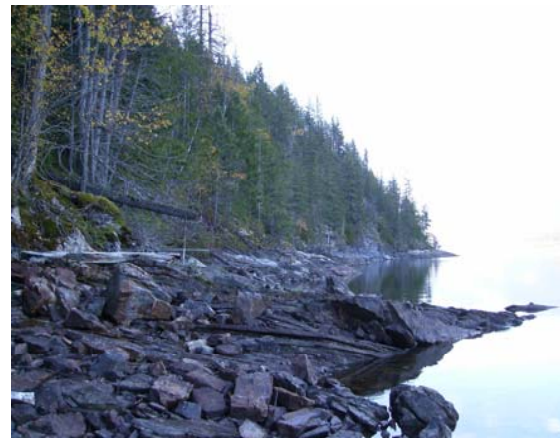
## Slocan Lake: Segment 26

Segment Length (m)	Shore Type	Shore Type Modification	Slope	Land Use	Level of Impact	Disturbed	Natural	Class Comment
22964	Rock	Dock, Groyne	Moderate	Natural	Low	1%	99%

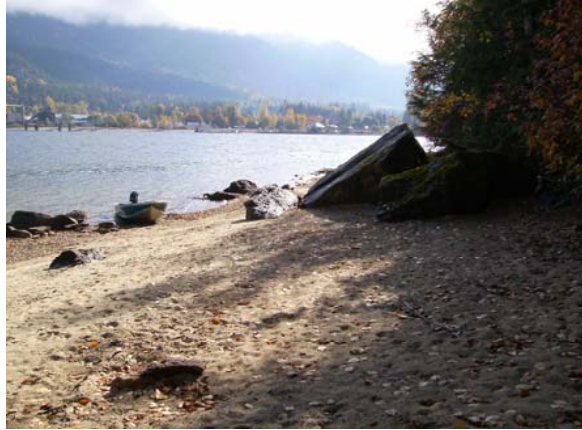
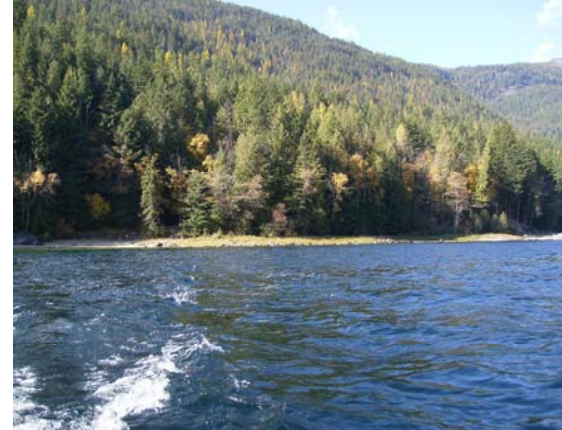
**Slocan Lake: Segment 27**

Segment Length (m)	Shore Type	Shore Type Modification	Slope	Land Use	Level of Impact	Disturbed	Natural	Class Comment
6567	Cliff/Bluff	Retaining Wall, Groyne	Moderate	Natural	Low	1%	99%

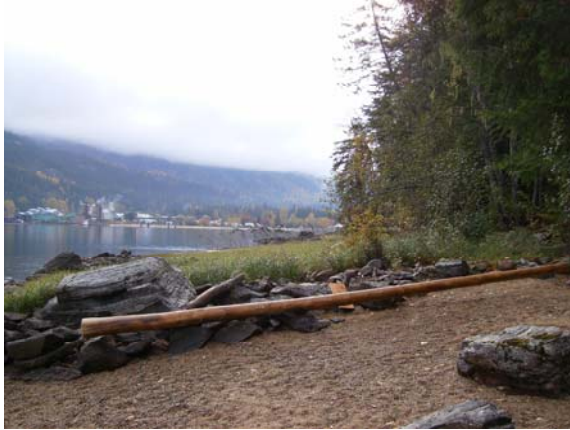
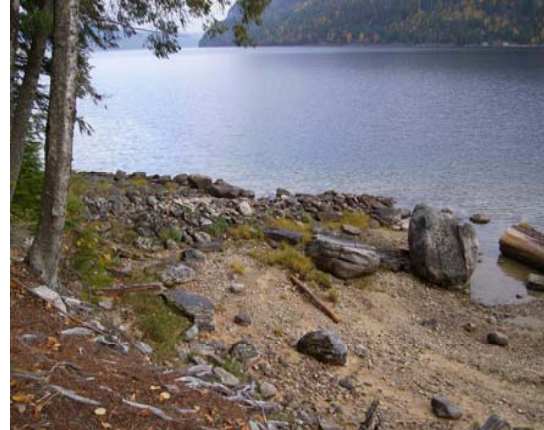
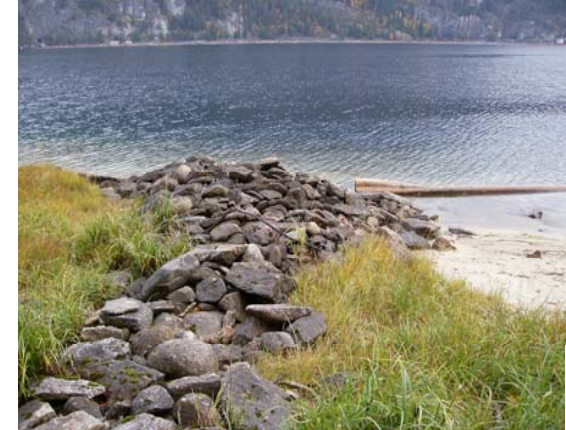
## Slocan Lake: Segment 28

Segment Length (m)	Shore Type	Shore Type Modification	Slope	Land Use	Level of Impact	Disturbed	Natural	Class Comment
711	Stream	Retaining Wall, Groyne	Moderate	Natural, Single Family	High	45%	55%
