Columbia Lake Foreshore Inventory and Mapping

Prepared for the East Kootenay Integrated Lake
Management Partnership

**Final Report
September 2009**

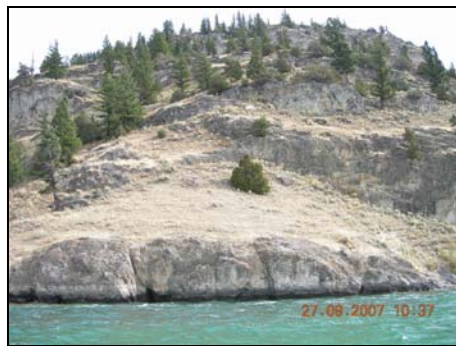
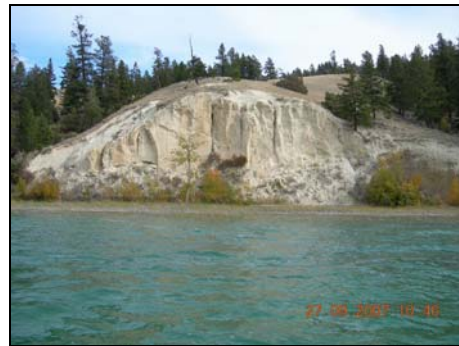
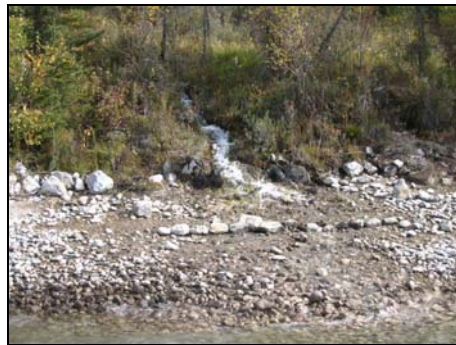
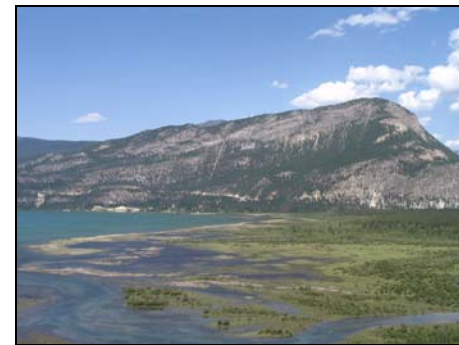
Cliff

Bluff

Gravel Beach

Wetland

Figure 6. Examples of Shore Types observed at Columbia Lake.

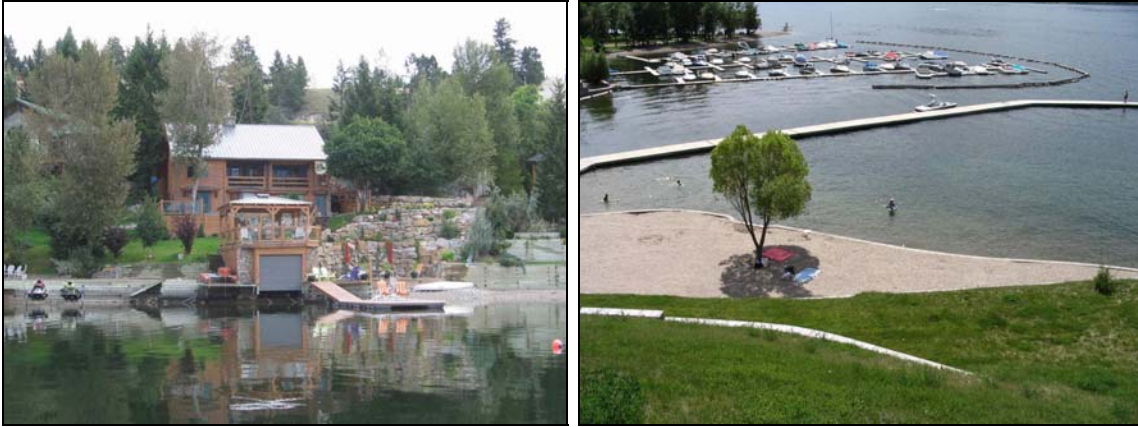
Figure 7. Examples of foreshore modifications including boathouse, dock, retaining wall (left); and marina, dock and retaining wall (right). Source: Windermere Lake photos - provided by Wildsight.

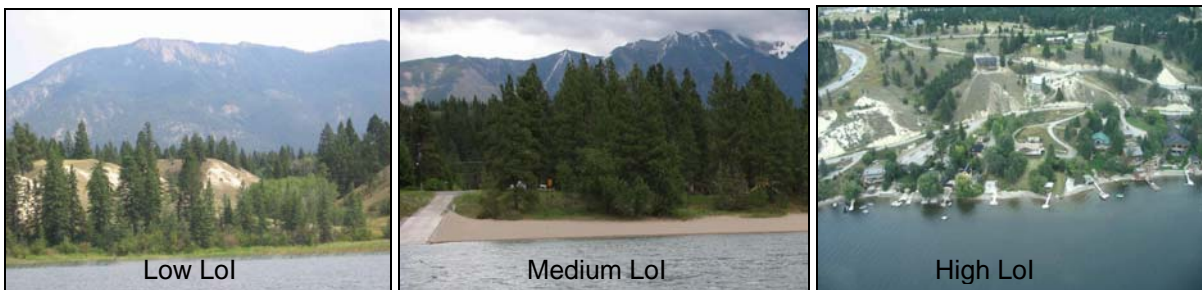
Figure 8. Examples of low, medium and high levels of impact along foreshore of lakes.

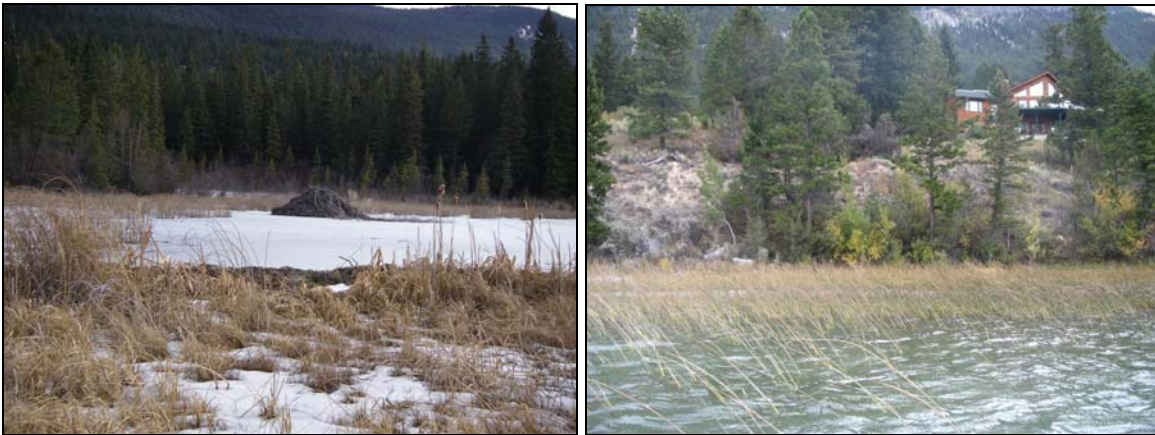
Figure 9. Wetland shore type or marsh wetland class (left) versus emergent vegetation area or shallow-water wetlands (right).

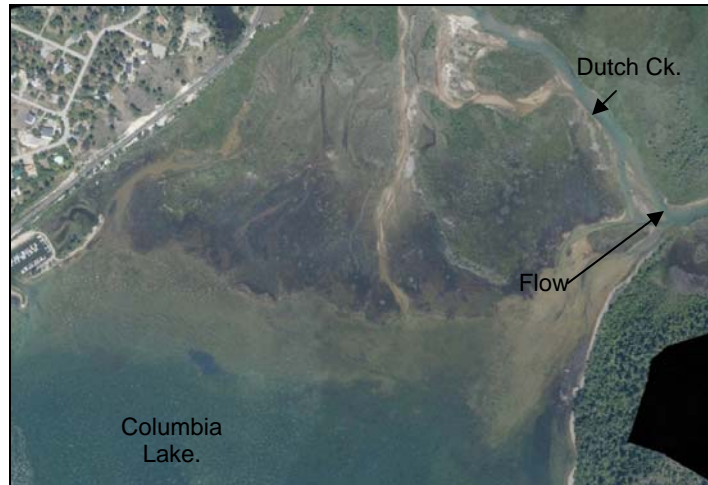
Figure 11. Dutch Creek alluvial fan at the north end of Columbia Lake. Orthophoto – July 2008.

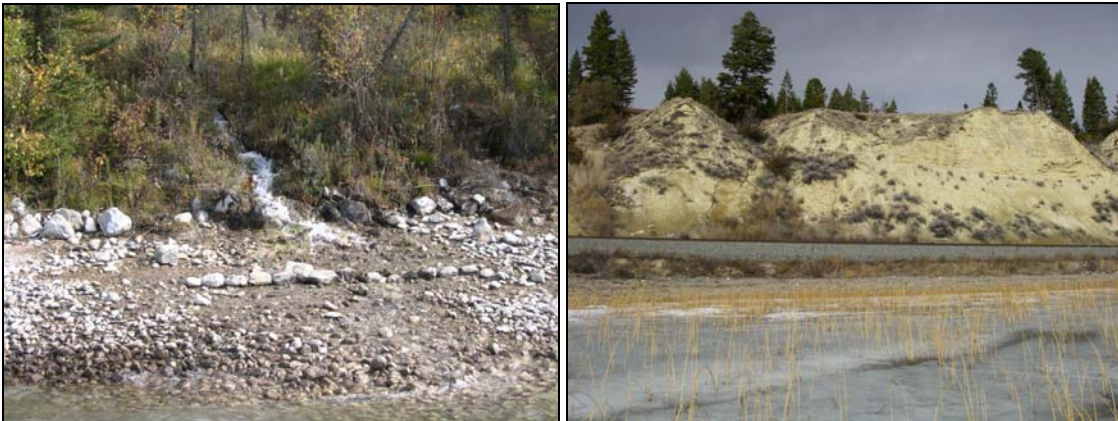
Figure 18. Gravel beach shore types - left photo shows beach backed by vegetated area along the eastern shore (Leschied Sept 2007) and the right shows railway and bluff features beyond (McPherson Mar 2009).

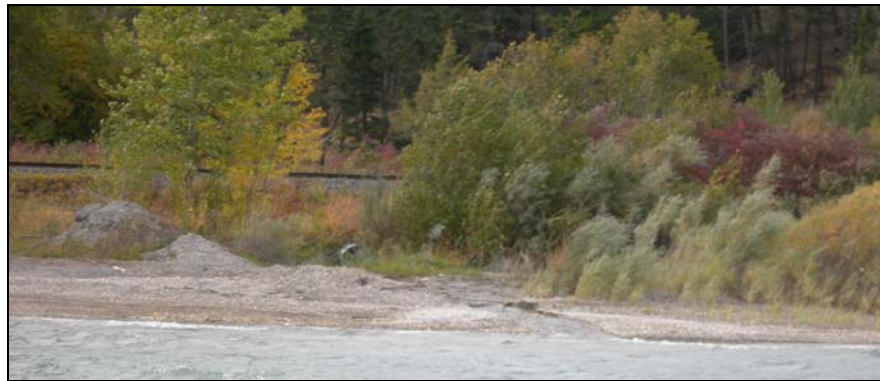
Figure 20. Marion Creek in Segment 7 entering lake through culvert under the railway. Photo: Porto Sept 2007.

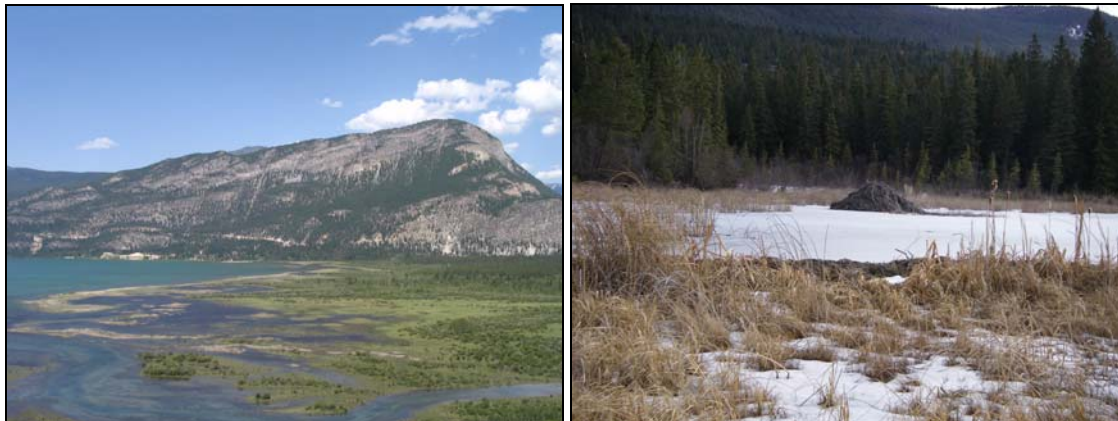
Wetlands are an important Shore Type along Columbia Lake. There are extensive wetlands at the north and south ends of the lake (Segments 4 and 8 respectively) and some along the east shore in the low lying areas between the bluffs (Segment 3) (Figure 21). All of these wetlands are incorporated in the WMA. In Segment 3, wetlands were found along approximately 15% (or 1,932 m) of the shore. Wetlands comprised 80% (or 3,571 m) of Segment 4 and 95% (or 6,755 m) of Segment 8.

Figure 21. View of south end wetland and unnamed creek (left photo: Leschied June 2007), and wetland along eastern shore in Segment 3 (right photo: McPherson 2009).

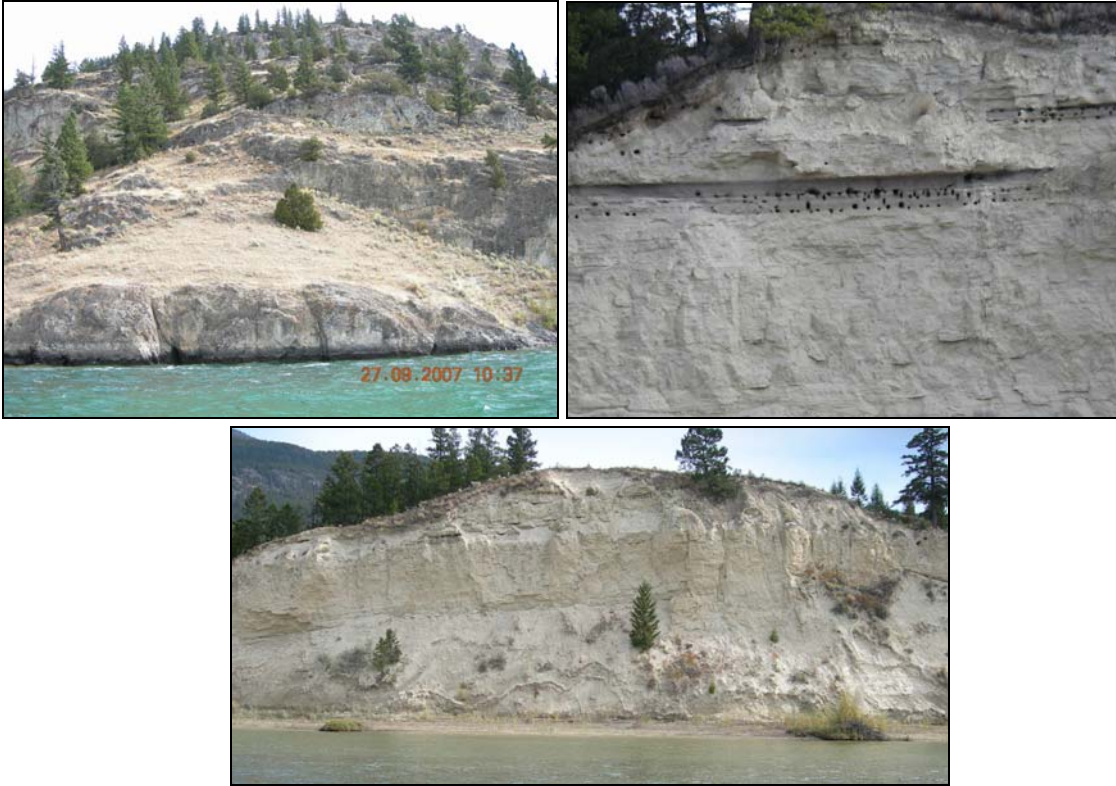
The cliffs and bluffs were distinguished from one another in this investigation since they provide different habitats and influences along the shoreline (See Methods). There was only a small extent of Cliff Shore Type, which was identified in Segment 2 (Figure 22). Conversely, Bluff Shore Type extended along substantial lengths of Segment 3, as well as Segments 6 and 7 (in the upland area beyond the railway).

Figure 22. Cliff Shore Type with steep shoreline in Segment 2 (top left, photo: Porto Sept 2007); Bluff Shore Type with swallow nest sites in Segment 3 (top right, photo: McPherson Mar 2009); and Bluff Shore Type with beach in Segment 3 (bottom photo: Porto Sept 2007).

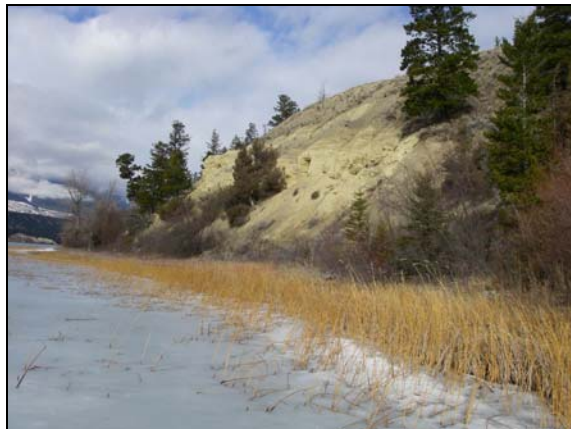
In Columbia Lake, emergent aquatic vegetation (shallow-water wetlands) was common along the shallow-water habitats of the littoral zone (Figure 23). The dominant emergent species was great bulrush (soft stem) and as provided by RDEK (2007), common pondweed also is expected to occur in some places. The emergent aquatic vegetation was mapped on the Foreshore Summary Maps (Appendix B).

Figure 23. Bulrush above the ice along the shoreline of Segment 3. Photo: McPherson, Mar 2009.

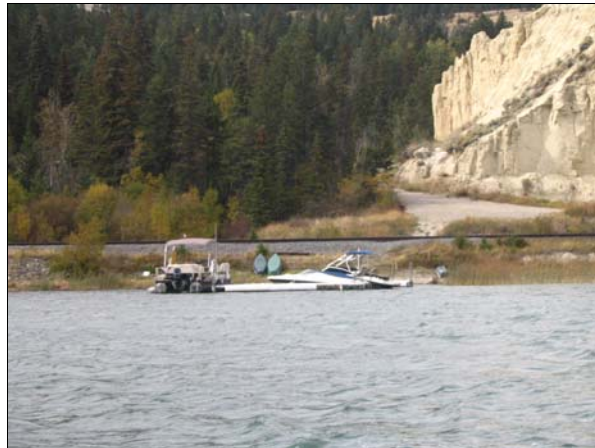
Figure 26. Sparse or no riparian vegetation was evident along the railway, as evidenced by this photo of Segment 6. Photo: Leschied Sept 2007.

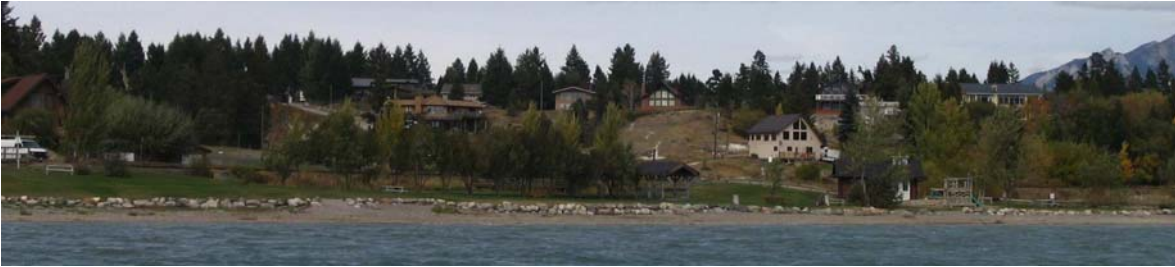
Along the west end of the lake, Segment 5 (Columere) had the greatest number of modifications, which included: a retaining wall (below high water mark), railway extending along 100% of shore, a dock and a groyne (Figure 30). Segment 5 also has a 70 slip marina. This marina is situated near the outlet of Dutch Creek and the WMA and within the vicinity of the withdrawal point for Columere's drinking water supply (RDEK 1997). The railway is the major modification along the remainder of the west side of the lake.

Figure 30. Shoreline modifications along Segment 5 (Columere) include retaining wall, riparian and aquatic vegetation removal and railway. Photo: Leschied Sept 2007.

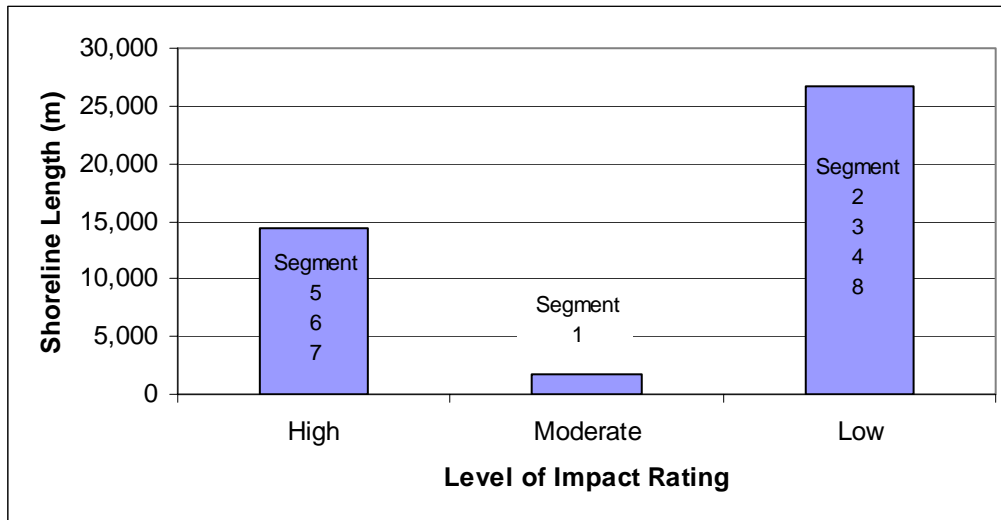
Lol provides a qualitative indication of the overall health of the foreshore and considers the land use, level of disturbance, and modification information presented above. Generally a High Lol refers to a segment with >40% alteration along its shoreline, a Moderate Lol is between 10 and 40% alteration, and a Low Lol segment is mainly natural with <10% alteration. However, modification density and type, extent of grooming of aquatic vegetation and riparian impacts also play a role in determining Lol. Figure 31 provides a summary of the Lol ratings for Columbia Lake, and reveals that 33% (14,337 m) of the foreshore was determined to have a High Lol, 4% (1,766 m) had a moderate Lol, and 62% (26,774 m) had a low Lol.

Figure 31. Segment level of impact (Lol) rating (High = >40%, Moderate = 10-40% and Low = <10%) and total shoreline length (m) attributed to each of the Lol ratings.

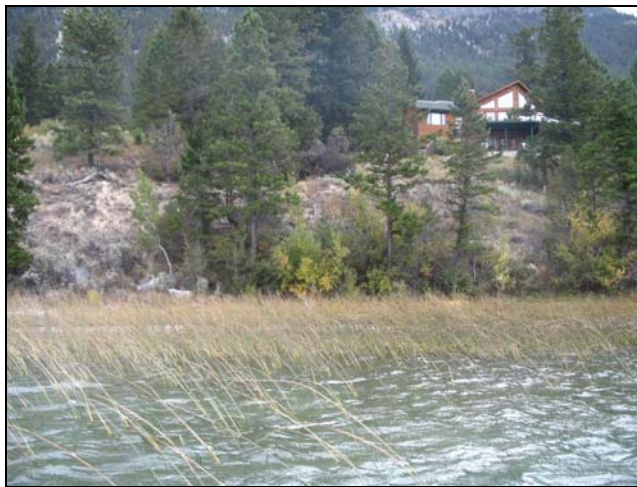
Figure 32. Residence set back on the bluff with minimal foreshore disturbance evident. Photo: Leschied Sept. 2007.

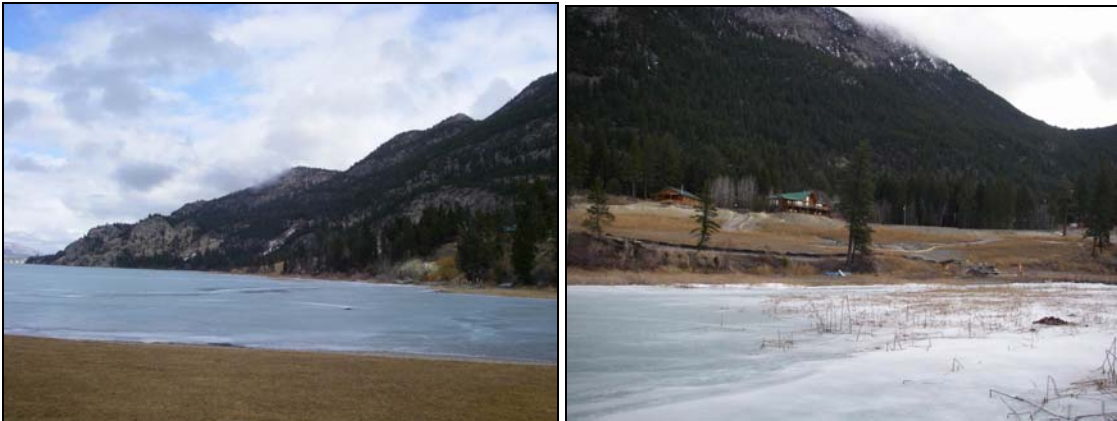
Segment 1. View to the south from the north end of Canal Flats Provincial (left), area under development) (right). Photos: McPherson, Mar 2009.

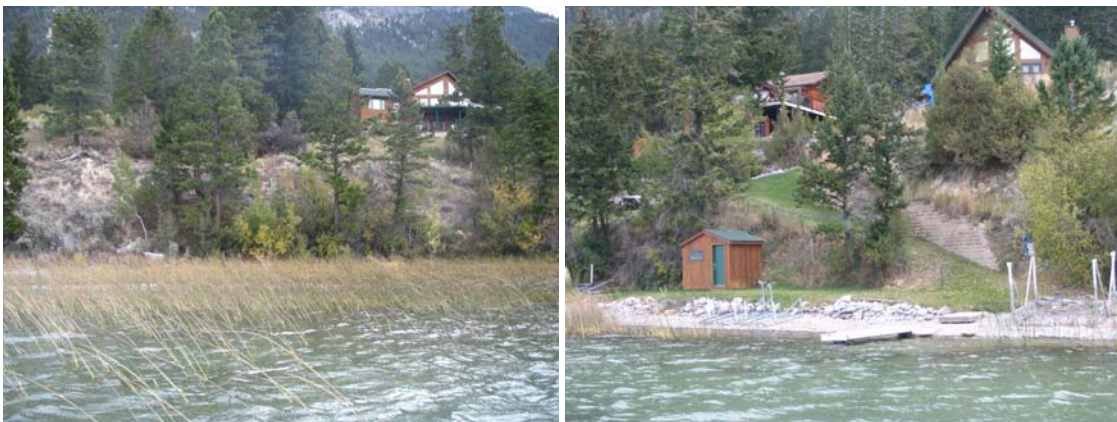
Segment 1. Emergent vegetation along bluff area (left photo: Porto Sept 2009), and developed foreshore property (right photo: Leschied, Sept 2009).

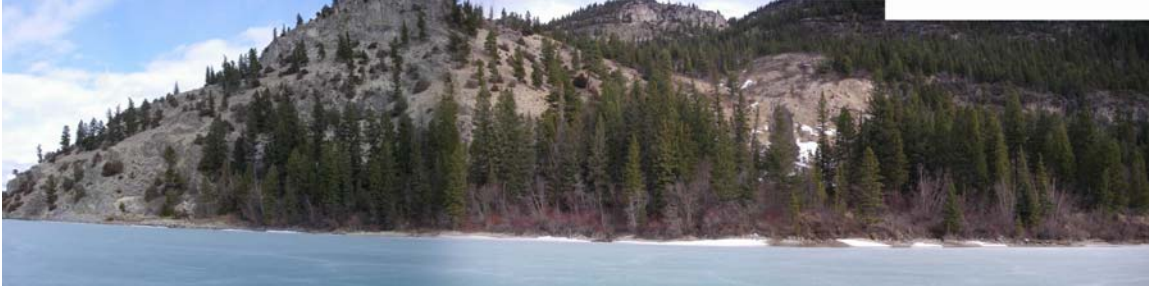
Segment 2: Cliff Shore Type alongside Gravel Beach in Segment 2. Photo: McPherson, Mar 2009.

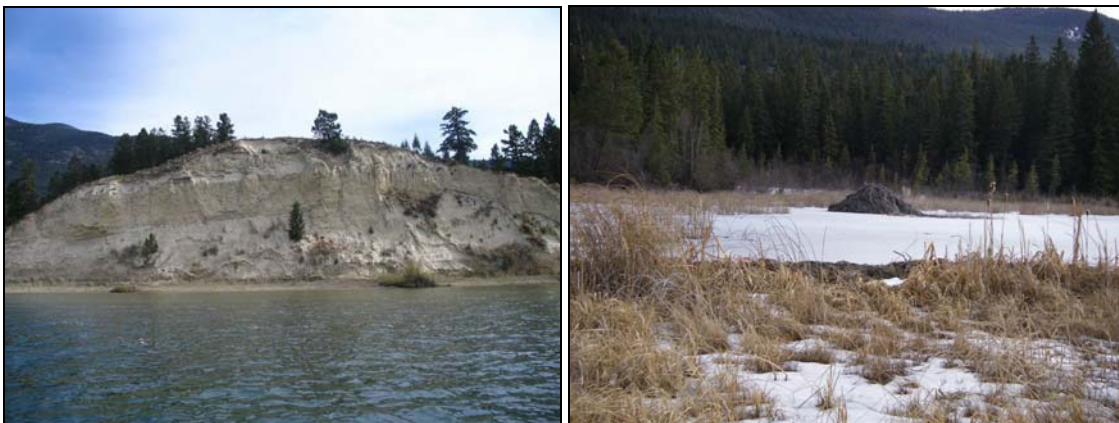
Segment 3. Bluff (left: Leschied, Sept 2007) and wetland Shore Types (right: McPherson, Mar 2009).

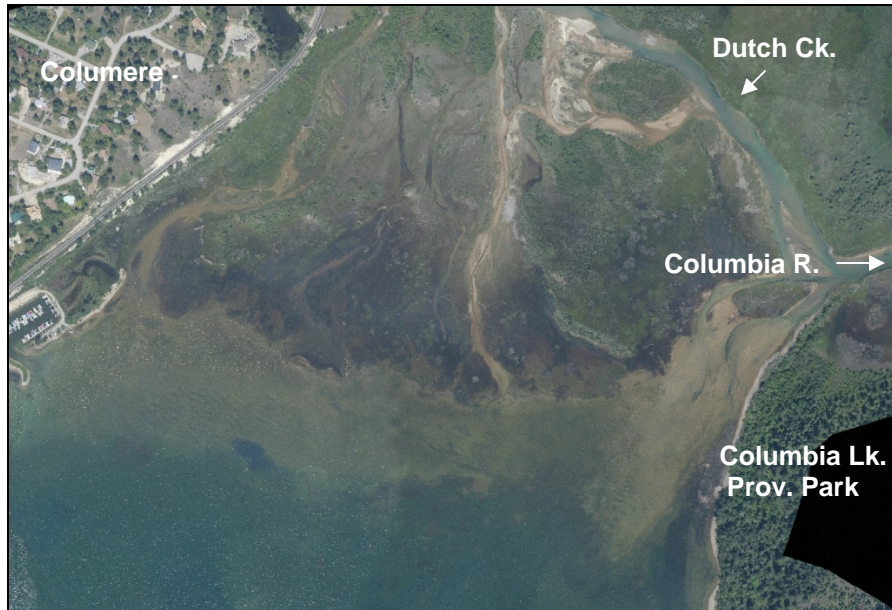
Segment 4. Overhead photo of wetland at north end of Columbia Lake. Photo: July 2008.

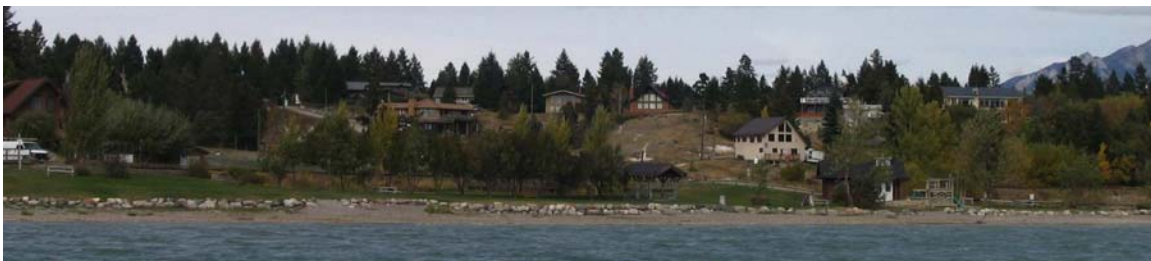
Segment 5. Columere shoreline, which has been largely altered from its natural condition (Photo: Leschied Sept 2007)

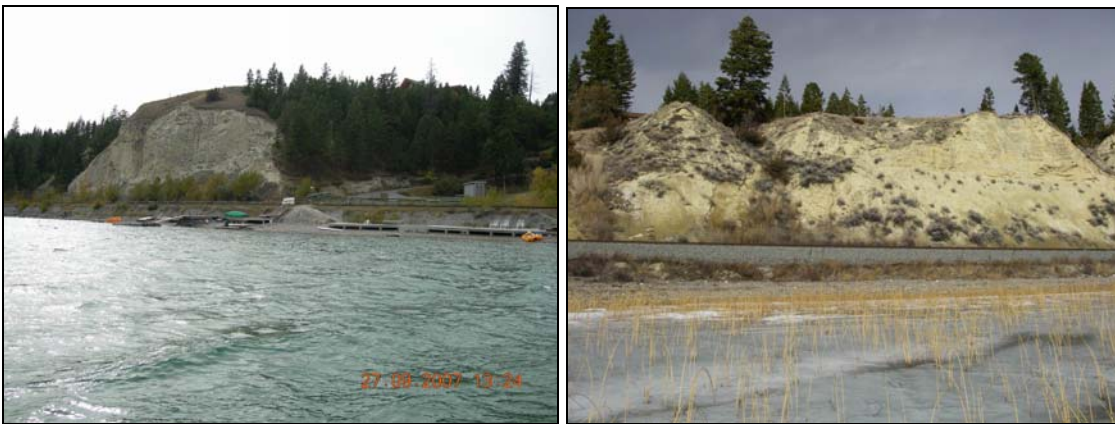
Segment 6. The cross section of the shoreline up from the lake in this segment is gravel beach, railway and then bluffs. Photos: left - Leschied Sept 2007, right - McPherson, Mar 2008.

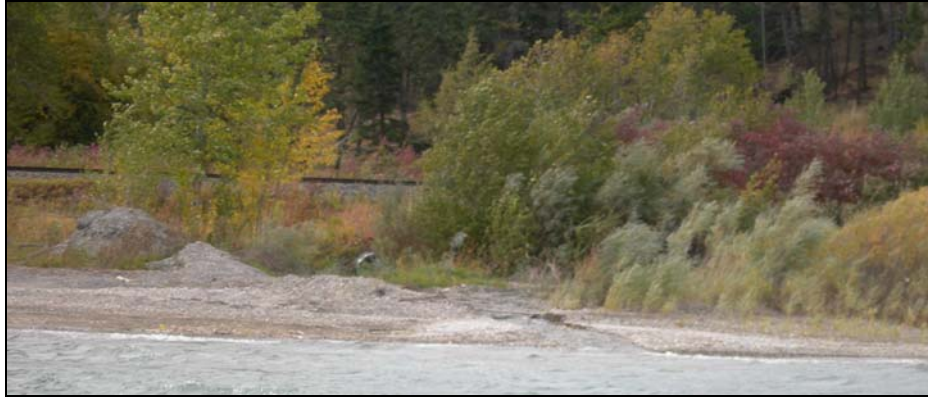
Segment 7. Marion Creek flow entering into the lake through a culvert under the railway. Photo: Porto Sept 2007.

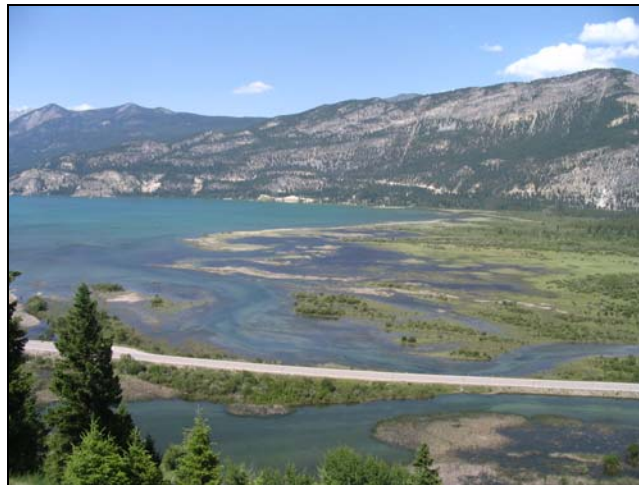
Segment 8. Looking east across highway towards the southern wetlands. Photo: Leschied, June 2007.
