**Windermere Lake
Foreshore Inventory and Mapping**

**Prepared for:
East Kootenay Integrated Lake Management
Partnership**

**Final Report
June 2007**

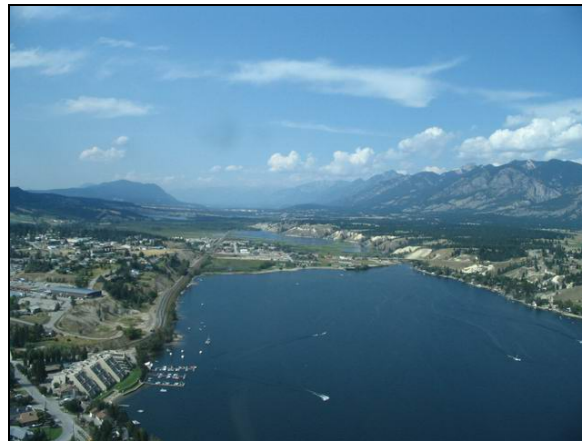
Figure 1. View towards north end of Windermere Lake, showing the District of Invermere along the North West boundary of the lake (area left of the lake outlet).

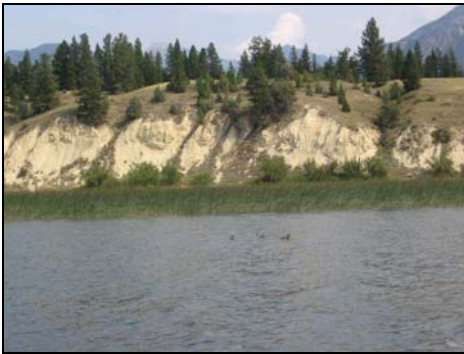
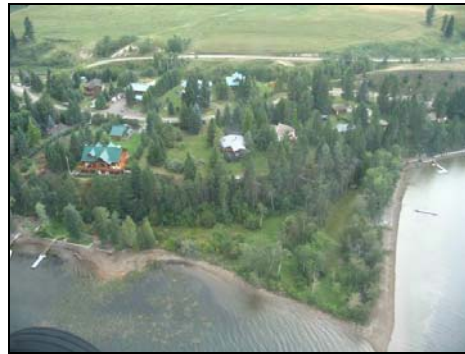
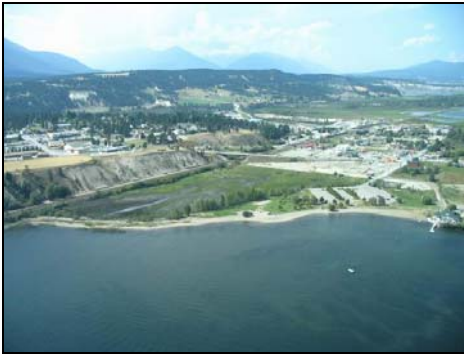
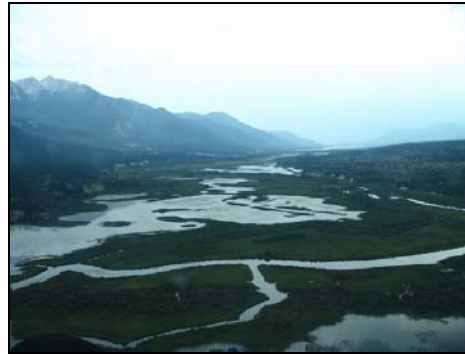
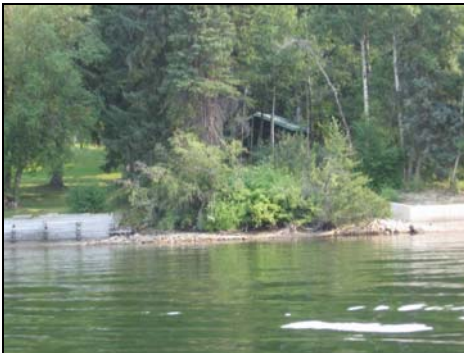
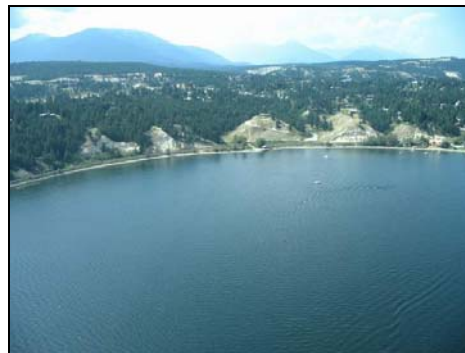
Figure 3. Examples of predominant shore types along Windermere Lake.

Cliff/bluff

Vegetated Shore

Sand Beach

Wetland

Gravel Beach

Low Rocky Shore

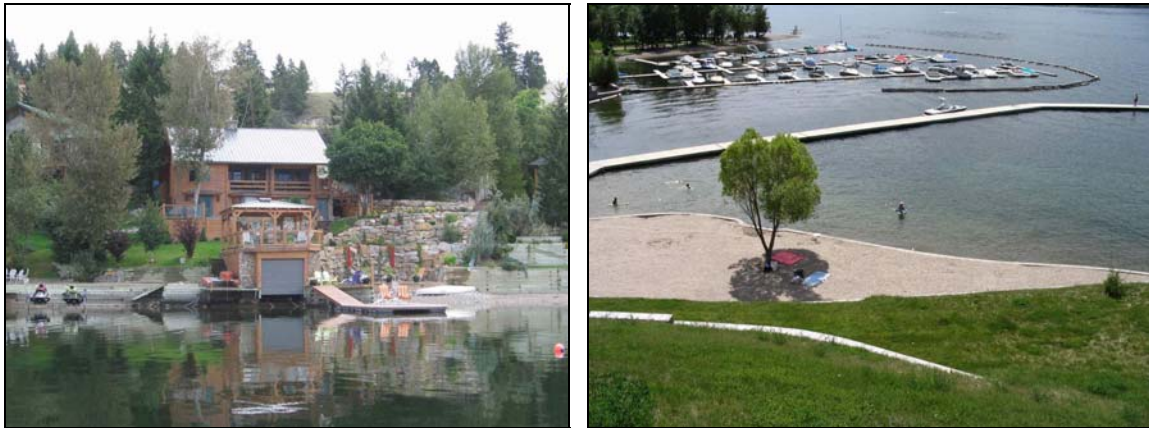
Figure 4. Examples of foreshore modifications along Windermere Lake, including boathouse, dock, retaining wall (left); and marina, dock and retaining wall (right, [photo provided by Wildsight]).

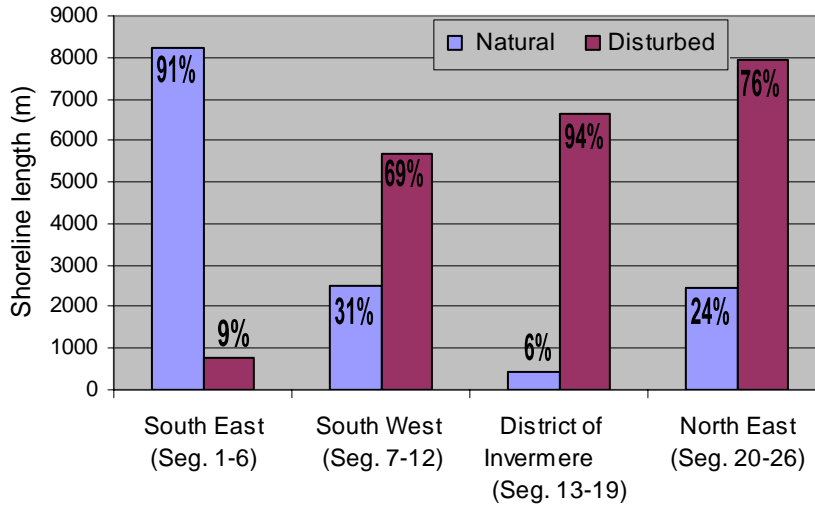
Figure 6 shows the extent of disturbed and natural foreshore area for each of the Segment groupings. Results indicate that shoreline disturbance is the least (9%) along the South East shore, and that disturbance is highest in the Segments within the District of Invermere (94%) and along the North East shore (76%).

Figure 6. Natural and disturbed values for each of the Segment groupings of Windermere Lake depicted as a length (m) of the total foreshore, and a percentage (%) of each Segment grouping.

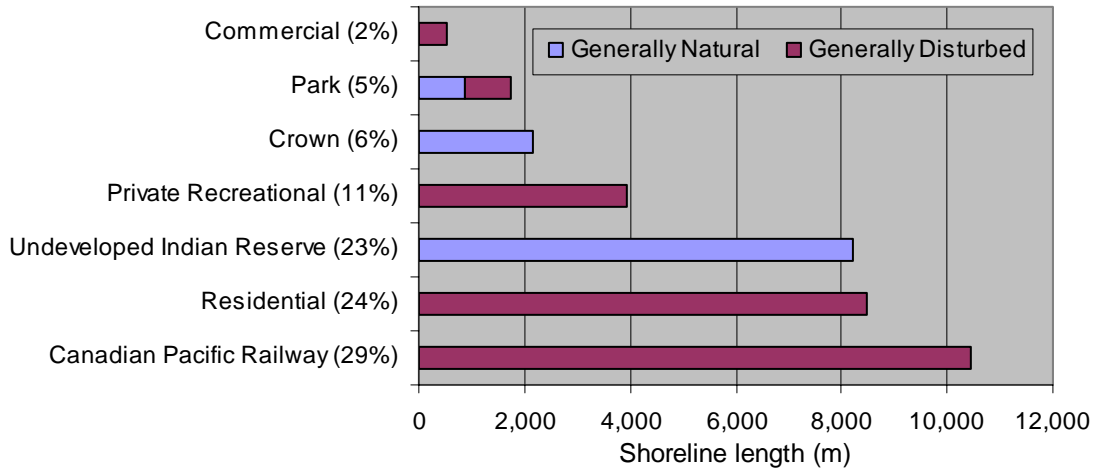
This assessment found that there are several primary land use types around Windermere Lake (Figure 7). Some of the land uses inherently have little impact on the foreshore conditions such as crown land and undeveloped Indian Reserve areas. Other land uses, by their nature, generally disturb the foreshore including the Canadian Pacific Railway (CPR), residential areas, private recreational areas, and commercial lands. The lake also has some parkland, which appear to be approximately half disturbed and half natural.

A review of the shoreline length for each of these land uses indicates that two land uses which result in disturbance, run along the longest lengths of shore. These are the CPR (spanning 10,440m or 29% of the shoreline) and residential development (spanning 8491m or 24% of the shoreline). Undeveloped Indian Reserve lands provide the most substantial foreshore length which has not been disturbed (8,226m or 23%). Private recreational properties generally have a moderate influence around the lake as a whole (3,933m or 11%); while crown, park and commercial land uses comprise the least foreshore length (respectively at 2,164m or 6%, 1756m or 5%, and 547m or 2%).

Figure 7. Land uses along the foreshore of Windermere Lake, depicted as length (m) coverage along shoreline, percentage of total foreshore length (%); with an indication of whether the land use generally maintains a natural condition or contributes to disturbance.

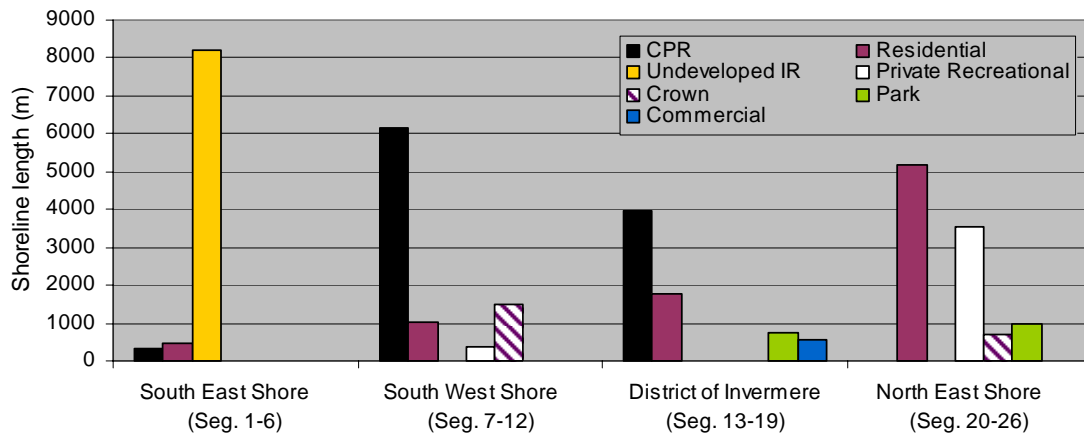
Figure 8 indicates where the primary land uses are generally located around the perimeter of Windermere Lake. From Figure 8, the following is evident: undeveloped Indian Reserve is concentrated in the Segments along the south east shore, the CPR runs along most of the eastern shoreline, most of the residential and private recreational areas are located along the north east shore, and that the small park areas are located in the District of Invermere and along the north east shoreline.

Figure 8. Land use type and extent (m) for each Segment grouping along the shoreline of Windermere Lake.

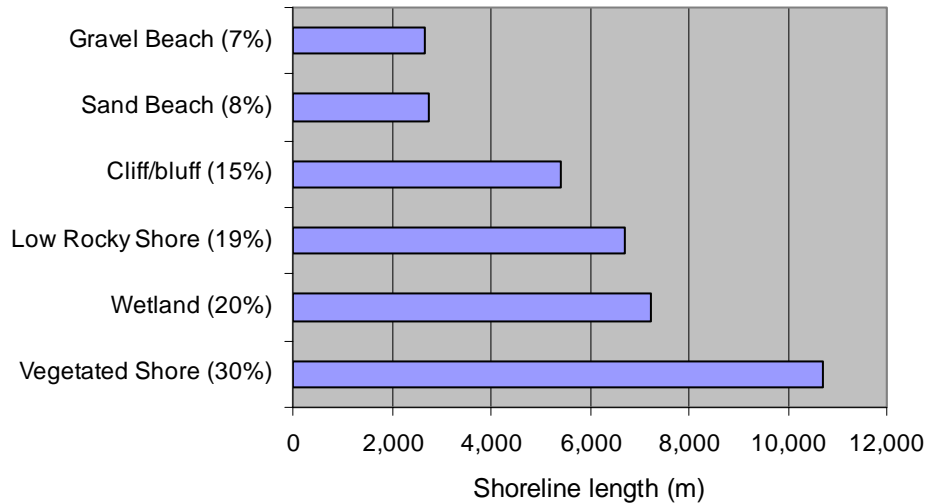
The foreshore of Windermere Lake is diverse containing vegetated, wetland, low rocky, cliff/bluff, sand beach and gravel beach types. A breakdown of the length and overall percentage of each of these shoreline types along the perimeter of the lake is provided in Figure 9. The foreshore is dominated by vegetated shoreline (10,718m, or 30%). Wetland, low rocky shore, and cliff/bluff types also make up substantial lengths of the shore at (7,240m, 6,689m, and 5,400m respectively), while sand and gravel beach areas (at 2,750m and 2,652m respectively) make up the smallest lengths of foreshore.

Figure 9. Length (m) and percentage (%) of total foreshore for each shore type along Windermere Lake.

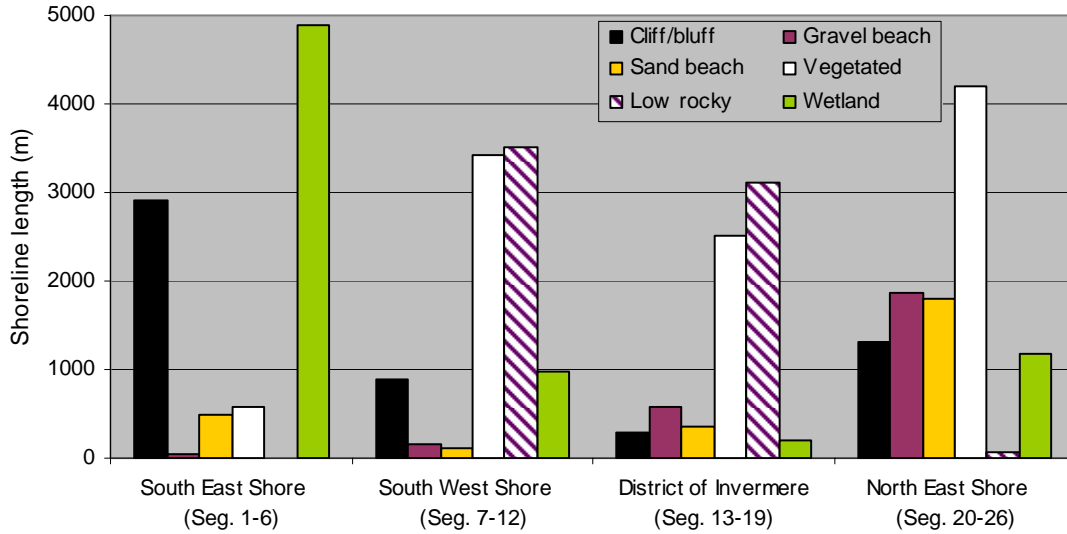
- each Segment grouping contains a variety of shoreline types;
- the south east shore contains the greatest extent of cliff/bluff (2,917m) and wetland (4,880m) areas;
- the south west shore and the District of Invermere both are mainly composed of vegetated shoreline and low rocky shoreline; and
- the north east shore is primarily vegetated shoreline type (4196m).

Figure 10. Shoreline Type and extent (m) for each Segment grouping along the shoreline of Windermere Lake.

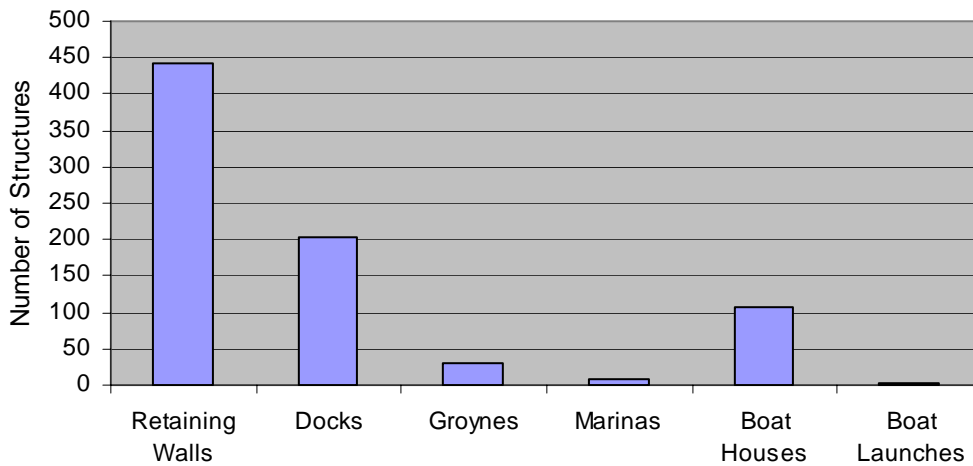
Foreshore modifications constructed along Windermere Lake include retaining walls, docks, groynes, marinas, boat houses, and boat launches. From Figure 11, it is evident that the greatest numbers of structures are retaining walls (443), docks (202), and boat houses (107). 29 groynes, 9 marinas, and 2 public boat launches were also noted during this review. Although not recorded during this project’s field assessment, 10 additional private boat launches exist along the foreshore (Leschied 2007).

Figure 11. Total number of modifications along the foreshore of Windermere Lake.

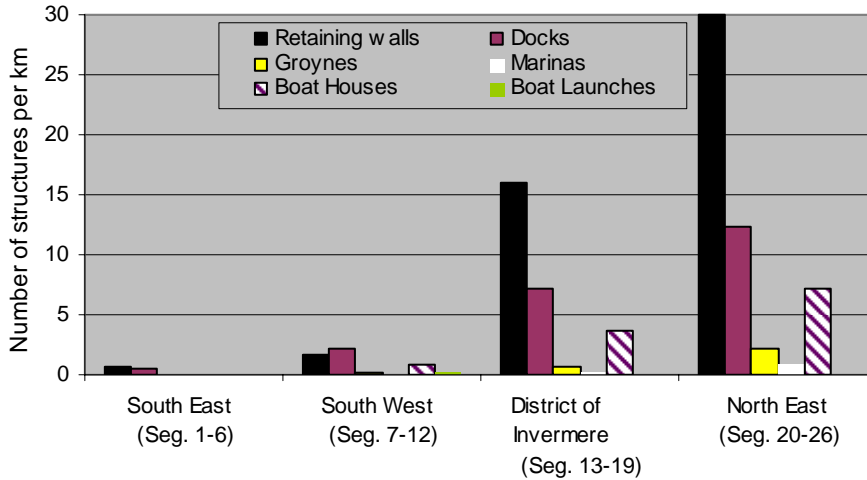
Segment grouping are as follows: 30 retaining walls/km, 12 docks/km, 7 boat houses/km, 2 groynes/km and, 1 marina/km.

Figure 12. Number of modifications (by type) per kilometre for each Segment grouping along the shoreline of Windermere Lake.

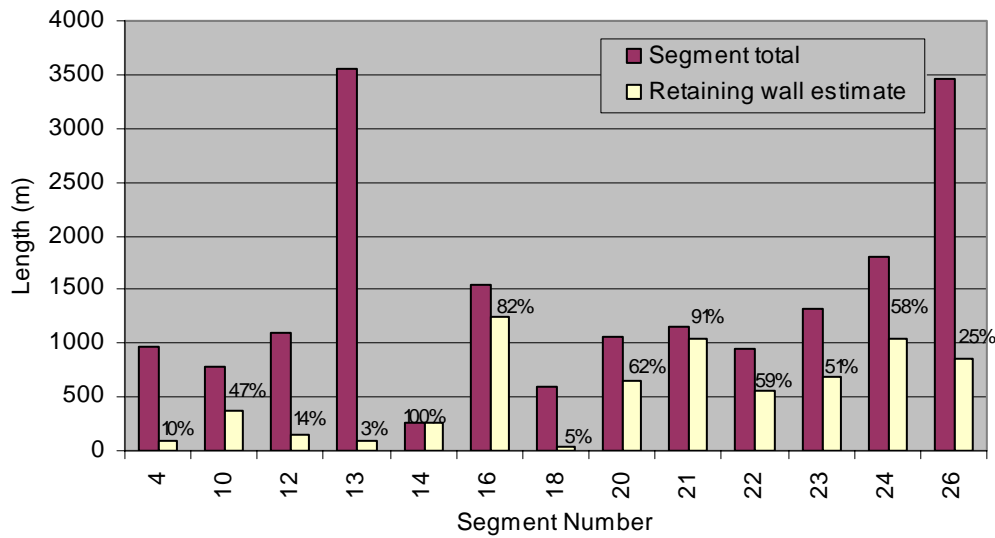
When the total length of retaining walls along each Segment is considered (Figure 13), there are several Segments with extensive coverage along their shorelines. For example, Segments 14, 16, 20, 21, 22, 23, 24, and 26 all have retaining walls along more than 50% of their total lengths. Segments 16, 21 and 24 have the greatest lengths of retaining walls at 1255m, 1048m, and 1051m respectively.

Figure 13. Total Segment length (m) and retaining wall length (m and % of total) for Segments with retaining walls present.

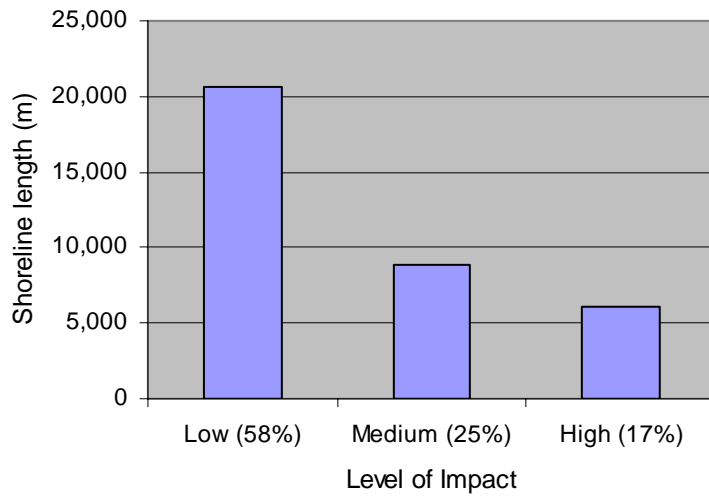
Lol provides a qualitative indication of the overall health of the foreshore and considers the land use, level of disturbance, and modification information presented above. Figure 14 provides a summary of the Lol ratings for Windermere Lake, and reveals that 58% (20,666m) of the shoreline has a low Lol, 25% (8,820m) has a medium Lol, and 17% (6,072m) has a high Lol.

Figure 14. Length (m) and percentage (%) of total foreshore area for each Level of Impact type (high, medium, low) along the foreshore of Windermere Lake.

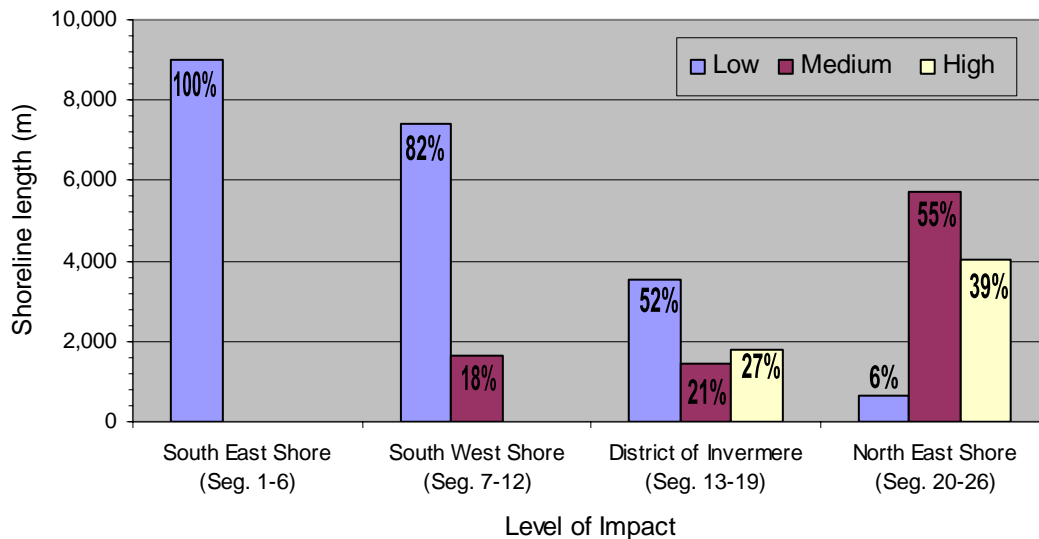
When Lol is compared for each of the Segment groupings (Figure 15), it is evident that the South East shore has been impacted the least (100% low Lol), followed by the South West shore (82% low Lol, and 18% medium Lol). The greatest impacts on Windermere Lake are evident along the North East shoreline, where 39% of the shore length is determined to have a high Lol, and 55% a medium Lol.

Figure 15. Level of Impact for each of the Windermere Lake Segment groupings, depicted as length (m) of the total shoreline, and as a percentage (%) of each Segment grouping.

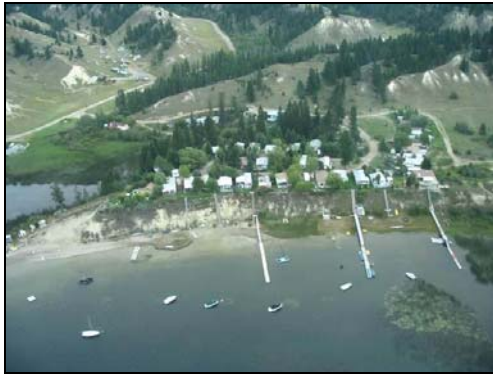
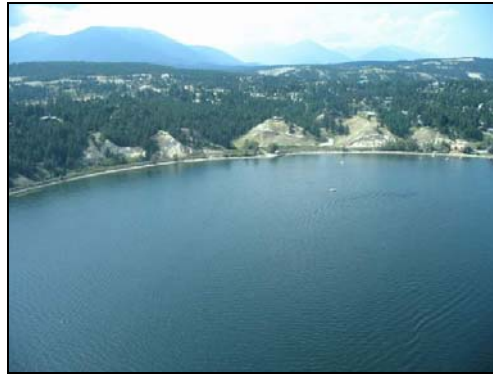
It is important to note that when Lol was determined for the foreshore areas of Windermere Lake, some areas were deemed to have a high disturbance level but an overall low Lol. This occurred mainly in Segments where the CPR was the primary Land Use Type, such as in Segments 11, 12 and 13. For these Segments, the railway was assessed to be a disturbance; however, the railway's presence did not affect the overall shoreline integrity to the same extent that other land uses, such as residential development would. Figure 16 portrays some examples of Segments with disturbance, but overall a low Lol.

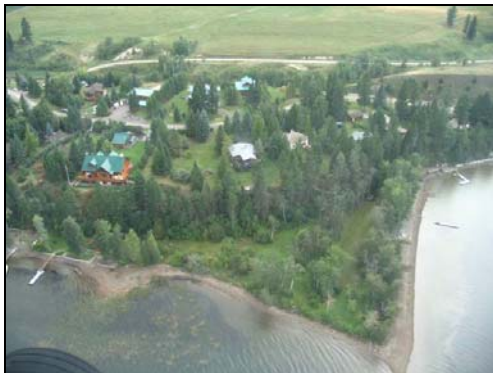
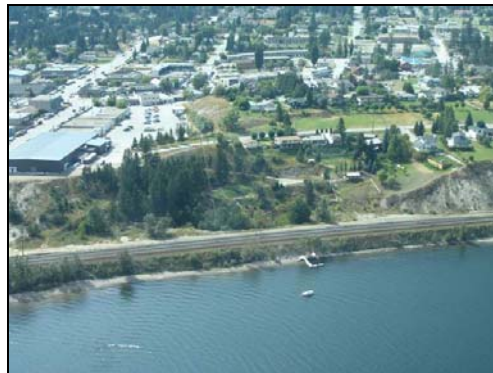
Segments with a medium Lol are dispersed around the lake, other than in the South East Segments. They include a variety of land use and shore types. Generally these Segments have been developed to some extent, but have not been disturbed as much (i.e. with shoreline modifications) or have not been developed as densely as those Segments rated with a high Lol. Figure 17 depicts example Segments with a medium Lol.

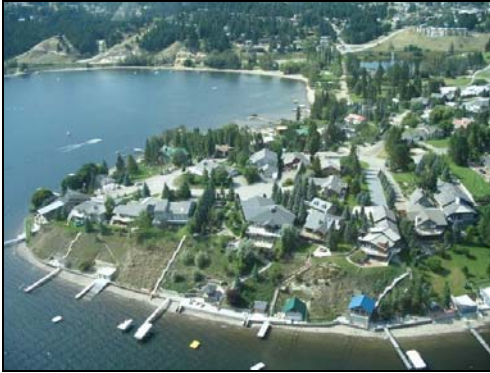
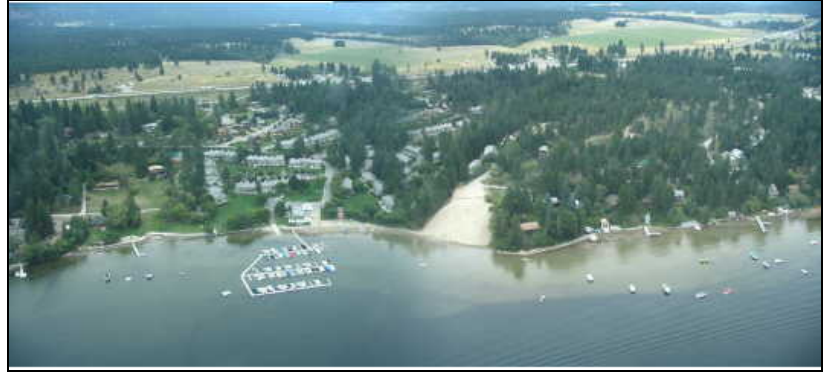
Residential and commercial areas associated with the Town of Invermere generally were determined to have a high Lol (Segments 14, 16 and 19). The densely populated residential areas and private recreational areas associated with the north east side of the lake also have high Lol's (Segments 20, 21 and 24). These areas are all primarily on low gradient shore types (vegetated or gravel beach). Figure 18 shows some of the high Lol areas around Windermere Lake.

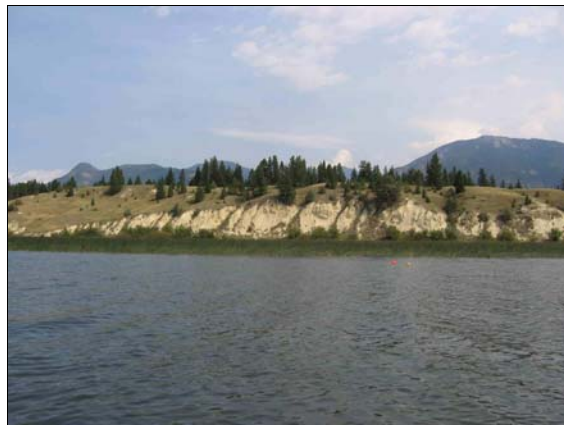
Figure 19. The foreshore along the south west side of Windermere Lake remains undisturbed.

Despite many foreshore impacts revealed by this project, a substantial portion of the foreshore within the study area remains undisturbed. The bulk of the undisturbed foreshore is located along the southeast shore (Figure 19). From the background review of species information for Windermere Lake, it is apparent that there are sensitive species/habitats associated with the undisturbed foreshore areas (i.e., south western grasslands and southern wetland areas) as well as the foreshore areas that have already been disturbed or that are in the vicinity of development (i.e. lake outlet at north end and outlet of Windermere Creek). These areas present a unique challenge to governing agencies responsible for balancing unprecedented growth with environmental protection. It is important to have preservation as a goal for the remaining intact ecosystems that exist along Windermere Lake.

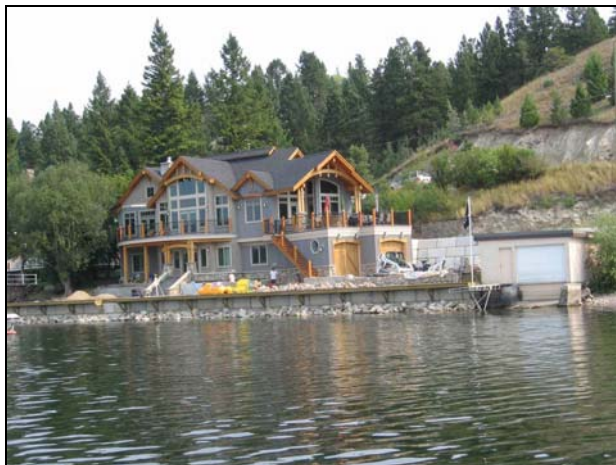
Figure 20. Foreshore modifications include removal of riparian vegetation, construction of retaining walls, docks, and boat houses.

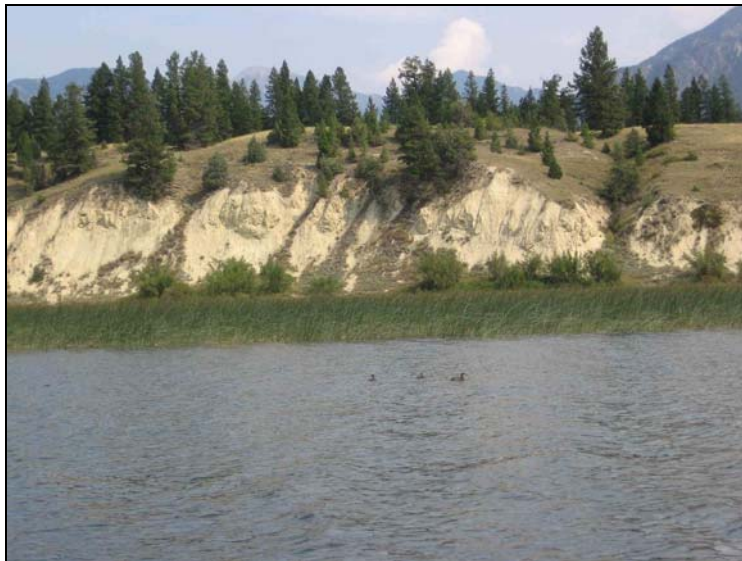
Segment 2 is located along Indian Reserve #3 and is in a natural condition. The shore type of this Segment is predominantly cliff/bluff (78%), with some vegetated shoreline area (12%). The riparian area is classified as a mixed forest, provides moderate cover, and is dominated by tall shrubs. There are some snags in this area (≥ 5). Sixty-two percent of the aquatic area contains submerged vegetation and 38% contains emergent vegetation. Swallow nests are evident in the banks, and turkey vultures and grebes were sited during the field review.

Figure 1. Segment 2 is undisturbed, is mainly cliff/bluff shoreline, and has an abundantly vegetated littoral area.

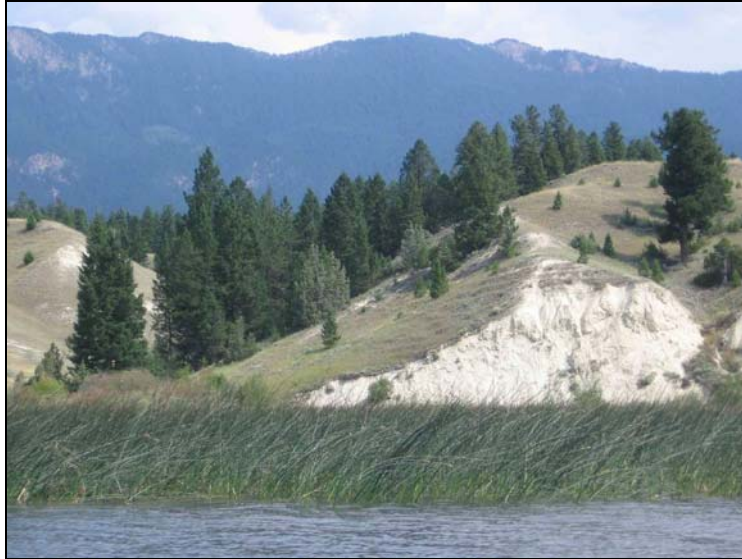
Segment 3, is located along Indian Reserve #3. This Segment is in a natural condition. The shore type is mainly a mix of cliff/bluff (45%) and wetland (45%), with some vegetated shoreline (10%). The riparian vegetation is classified as a mixed forest, and the area is abundantly vegetated (>20%), mostly with tall shrubs. A number of veteran trees exist in this Segment (≥ 5). Much of the aquatic area is vegetated with 65% covered by submergent and 35% with emergent vegetation types. During the field review the following wildlife features/sightings were noted: a large diameter wildlife tree with a large cavity, a large burrow, osprey, and grebes.

Figure 2. The south east side of Windermere Lake remains generally unaltered. The cliff/bluff and wetland shore types as seen here in Segment 3 are found along much of this portion of the lake.

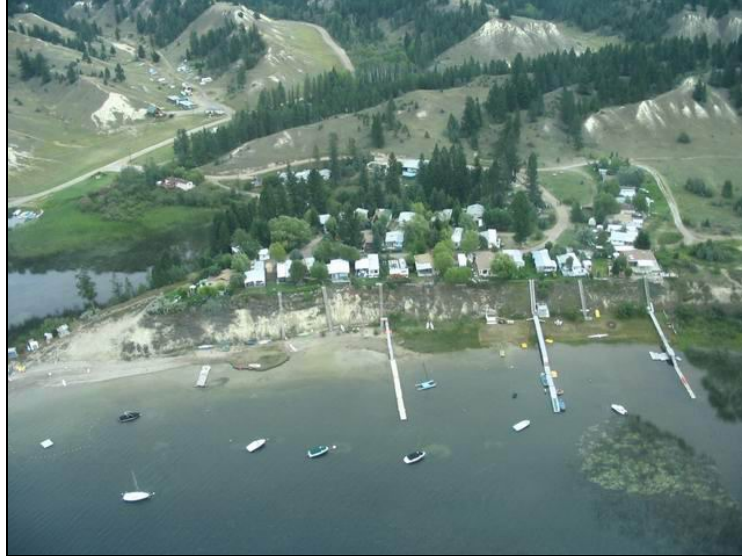
This Segment is in the Indian Reserve #3, and includes a residential area. Although approximately 50% of this shoreline Segment has urban development, the remaining 50% is in a natural condition, and the overall impact to the shoreline remains low. This site is mainly sandy beach (50%), with some cliff/bluff (20%), wetland (25%), and gravel beach (5%) shore types. Riparian vegetative cover is sparse in this Segment with the mixed mature forest providing less than 5% cover to the area. Six wood retaining walls have been constructed along the shoreline below the dwellings. Five wooden docks are also present. A high value wetland is located at the tributary mouth in this Segment with 80% of the aquatic area estimated to contain submergent vegetation and 20% emergent vegetation.

Figure 3. Urban development in Segment 5 comprises approx. 50% of the shoreline, and the remaining area is in a natural condition.

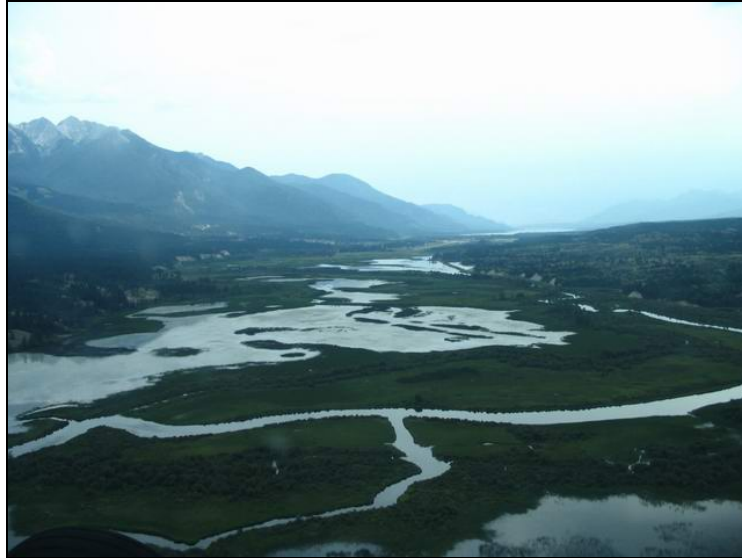
Segment 6 encompasses the southern tip of the Windermere Lake. Other than a small section (approximately 10% of area) on the western side being occupied by the Canadian Pacific Railway (CPR), most of the shoreline is in IR3 and is a natural wetland. The riparian area is aptly classified as natural wetland and riparian cover is abundant ($> 20\%$). Fifty-five percent of the aquatic area is covered by submerged vegetation and 45% by emergent vegetation.

Figure 4. Segment 6 is undisturbed wetland area.

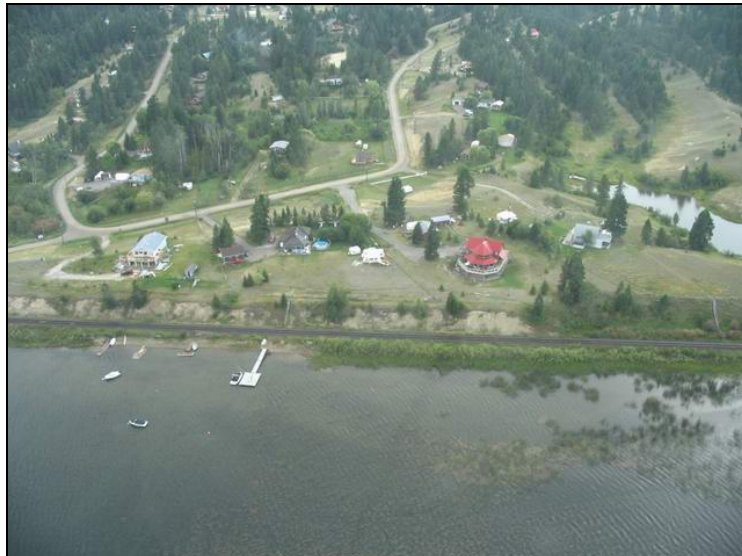
The CPR runs along the entire shoreline length of Segment 7. As well, the northern part of this Segment contains a residential development immediately behind the railway (for approximately 20% of the Segment). Due to these land issues, 100% of the shoreline is estimated to be disturbed. The shore type of this section is a mix of cliff/bluff, wetland, and low rocky shore (each at 30%) as well as vegetated shoreline (10%). The riparian vegetation is disturbed, sparse (providing less than 5% shore cover), and where evident, is predominantly tall shrubs. Ninety percent of the aquatic area is vegetated with submerged plants, while 10% contains emergent vegetation. Seven wooden docks have been constructed along the shoreline.

Figure 5. The CPR runs the length of Segment 7, and some residential area lies beyond (the railway) in the northern end.

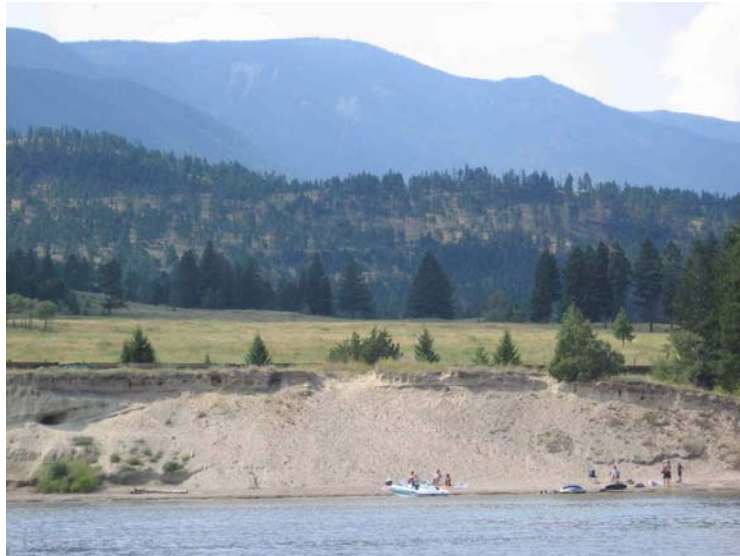
Figure 6. This portion of Segment 8 has not been disturbed by residential development, but has been impacted by the railway.

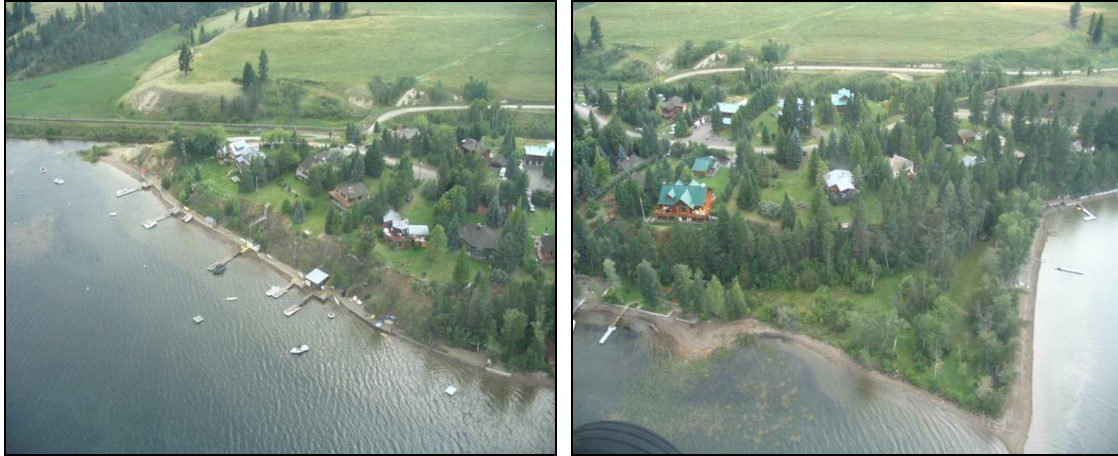
Figure 7. The attributes of Segment 10 are evident in these photos, which show moderate impacts on the shoreline as a result of residential development.

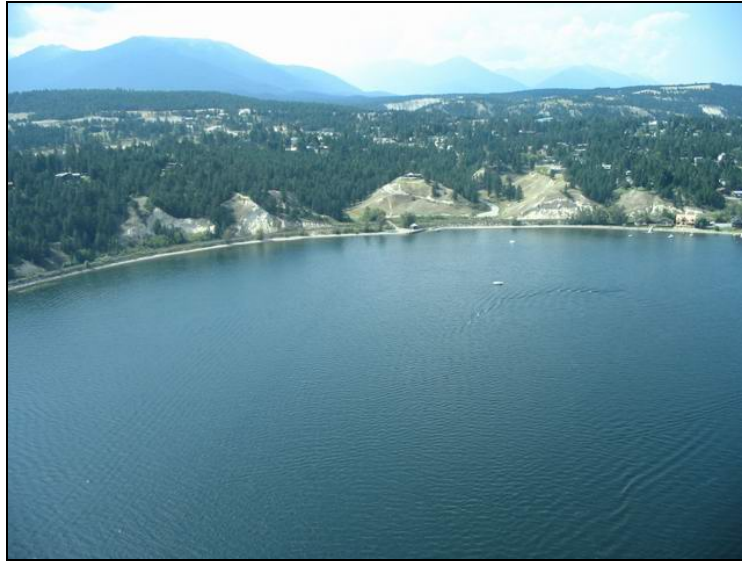
4.3 Shoreline Type

This Segment is located on private land, and is located on the southern outskirts and just within the boundaries of the District of Invermere. It is mainly low rocky shore (80%), and also includes vegetated shore type (15%) and wetland areas (5%). The CPR runs the length of this Segment and contributes to its disturbed condition (100%). The riparian area shows disturbance, and is mainly mature coniferous forest that provides moderate coverage to the foreshore. Riparian veterans and snags (≥ 5 for each) are present. Ninety-five percent of the aquatic community is vegetated with submerged plants, while 5% has emergent plants. The isolated wetland in this Segment is considered high value, and motorized impacts were noted on the upland grasslands during the survey.

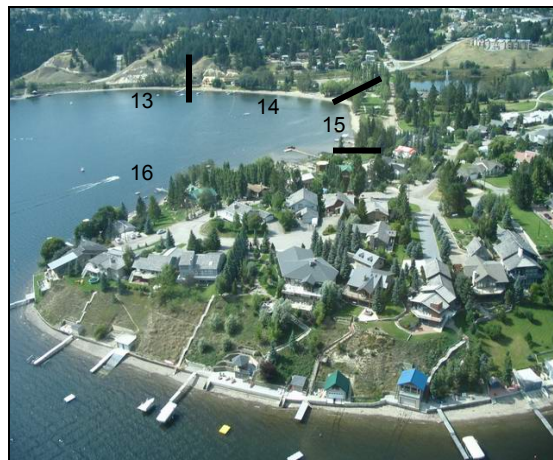
Figure 10. Urban development along the shoreline of Segment 16 includes dock and retaining wall shoreline modifications.

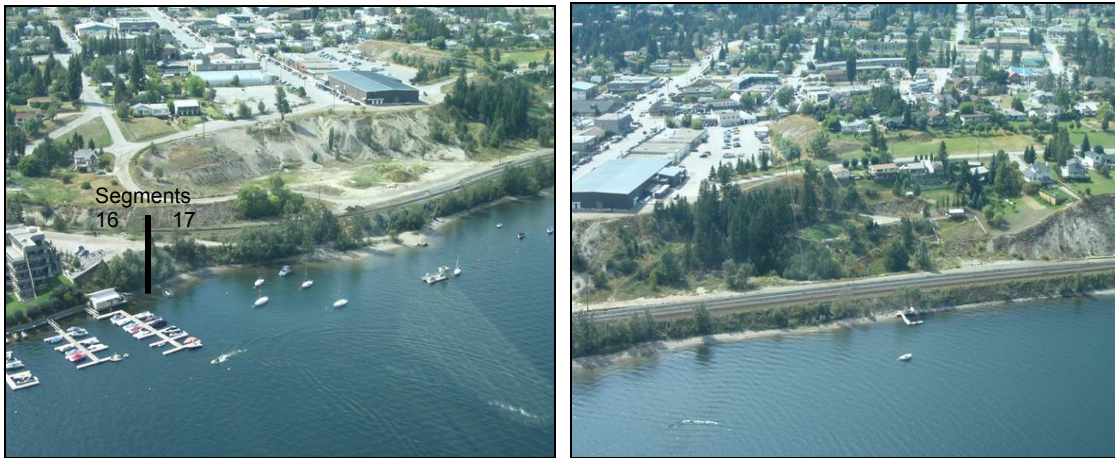
The shore type of Segment 17 is a mixture of vegetated rocky shore (40%), low rocky shore (40%), and cliff/bluff shore (20%). Approximately 70% of this site is estimated to have been disturbed. The CPR runs along 60% of this Segment, and the remainder of the shoreline (40%) is commercial development. Further disturbance to this Segment is expected since it is adjacent to downtown Invermere, and plans are in place for a resort development. Although disturbed, the

riparian area provides abundant cover to this Segment, and is primarily made up of broadleaf saplings >10m. There is little aquatic vegetation here (10% submerged). Three wooden docks and 1 concrete groyne have been built.

Figure 11. Shoreline along Segment 17, showing location for water side resort development (LHS) and downtown Invermere beyond the shoreline (RHS).

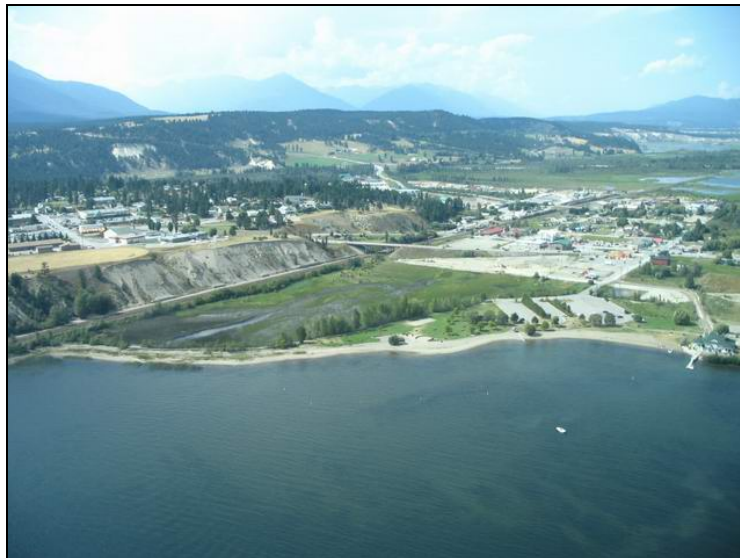
Segment 18 runs along James Chabot Provincial Park (100% park). The shoreline is mainly gravel beach (45%) and sand beach (45%) shore types. A valuable wetland area also comprises 5% of the shoreline. Approximately 40% of this Segment remains in a natural condition. The riparian area provides abundant cover of herbs/grasses (mainly low shrubs <2m). Approximately 15% of the aquatic area in this Segment contains submerged vegetation, while 10% contains emergent vegetation. There is 1 wooden dock, 1 wooden retaining wall, and a boardwalk in this Segment. An Osprey nest is located in the parking lot.

Figure 12. Segment 18 is bordered by James Chabot Provincial Park.

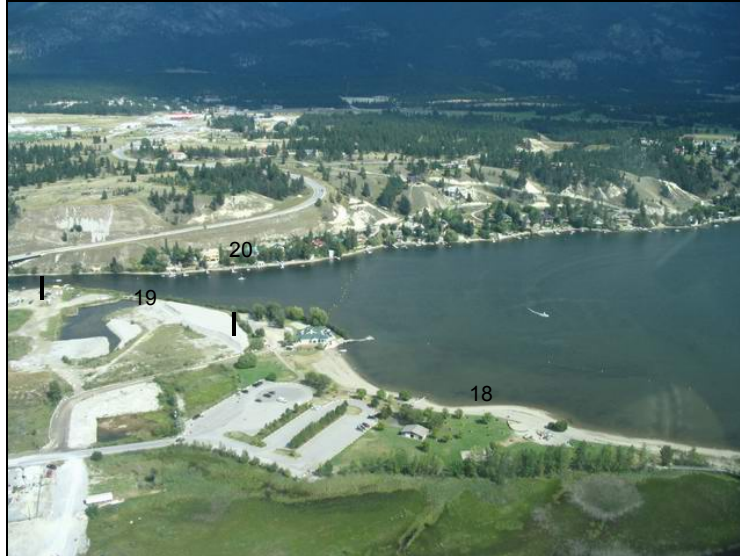
Segment 19 is located at the outlet of Windermere Lake. This Segment is vegetated shore line, which has been 100% disturbed. It is all commercial land use and has a hotel/convention centre planned for construction. Some current sources of the disturbance are 1 wooden retaining wall, and a clearing at a site of a future resort. The riparian vegetation consists of tall shrubs, which provide moderate coverage to the area. The aquatic area contains 65% coverage with submerged vegetation and 35% with other vegetation. The area is highly used by waterfowl. There is a public easement along the shoreline allowing for pedestrian access.

Figure 13. Segment 19 located at the outlet of Windermere Lake, is the shoreline area between the markers in this photo.

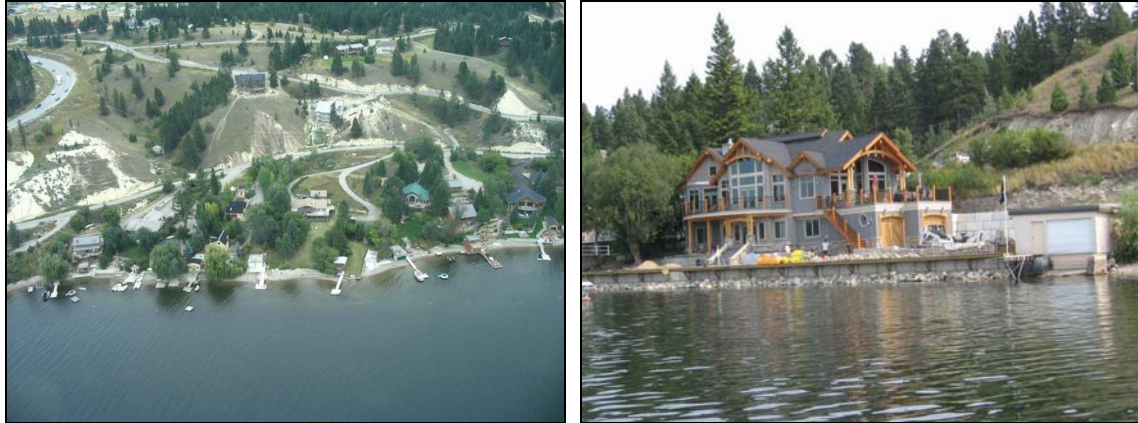
Figure 14. Most of the shoreline along Segment 20 has disturbed by residential development.

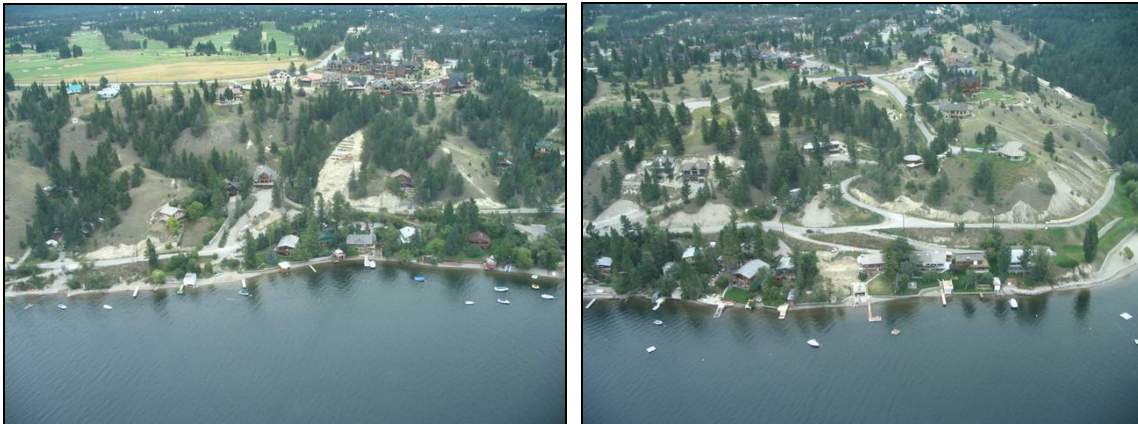
This Segment has been disturbed by residential development, which covers 100% of the area. The shore type here is predominantly vegetated (50%), although there is also a substantial amount of gravel beach (40%), as well as some cliff/bluff and low rocky shore (5% each). The riparian vegetation is composed of a mixed mature forest, which provides moderate coverage to the area. Forty percent of the aquatic area is covered with submerged aquatic vegetation. There are numerous structures built along the shoreline including 80 retaining walls (mixed construction materials), 27 wooden docks, 9 stonework groynes, and 26 boathouses.

Figure 15. Lower Lake View Road along Segment 21.

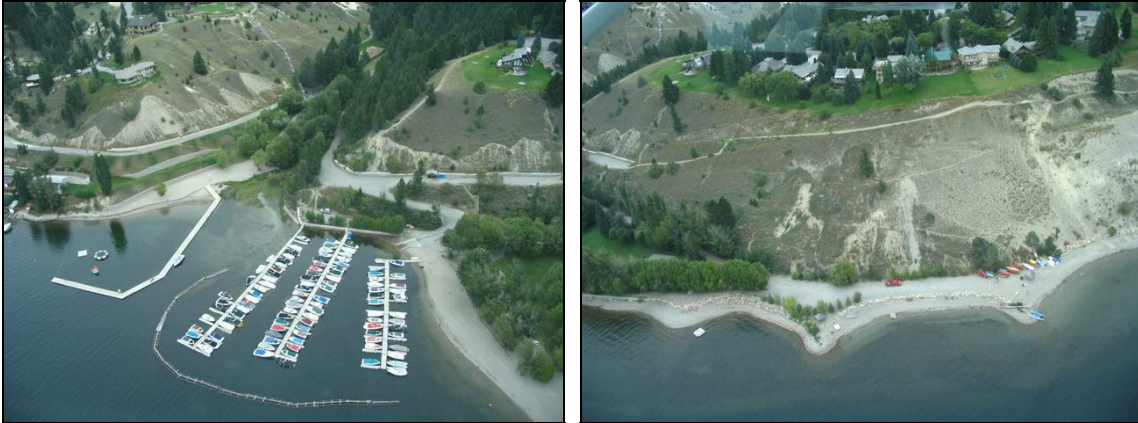
- the mouth of Holland Creek provides important wetland habitat and is used by Kokanee moving in and out of Holland Creek;
- wildlife tracks were observed from the lake to a burrow located in the clay bank;
- the natural grassland slope is high value; and

Figure 16. North end of Segment 22 showing the public park along the north side of Holland Creek, and the Timber Ridge marina and beach private recreational properties.

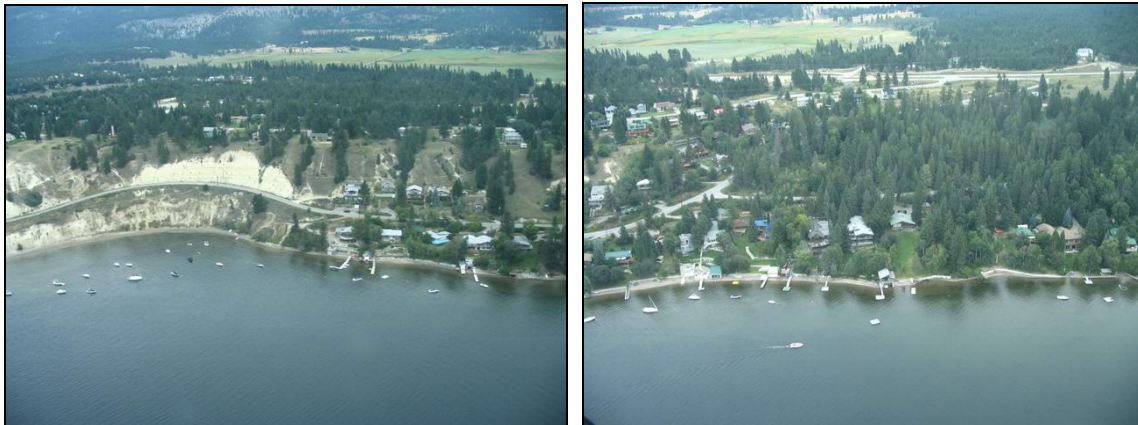
Eighty percent of Segment 23 consists of residential properties, and the remaining 20% is private recreational property (i.e. Baltac Beach). These land uses are estimated to have disturbed 75% of the foreshore. The shore type here is a mix of vegetated shore (40%), cliff/bluff (25%), and sand beach (35%). The riparian vegetation is made up of a mature broadleaf forest that provides abundant cover to the shoreline. Structures built along the shoreline include 88 retaining walls (mixed materials), 18 wooden docks, 2 stonework groynes, 1 marina, and 12 boathouses. Bank erosion is evident along the exposed bank areas.

Figure 17. Segment 23 showing the Baltac Beach (private) on the left and the Baltac residential community on the right

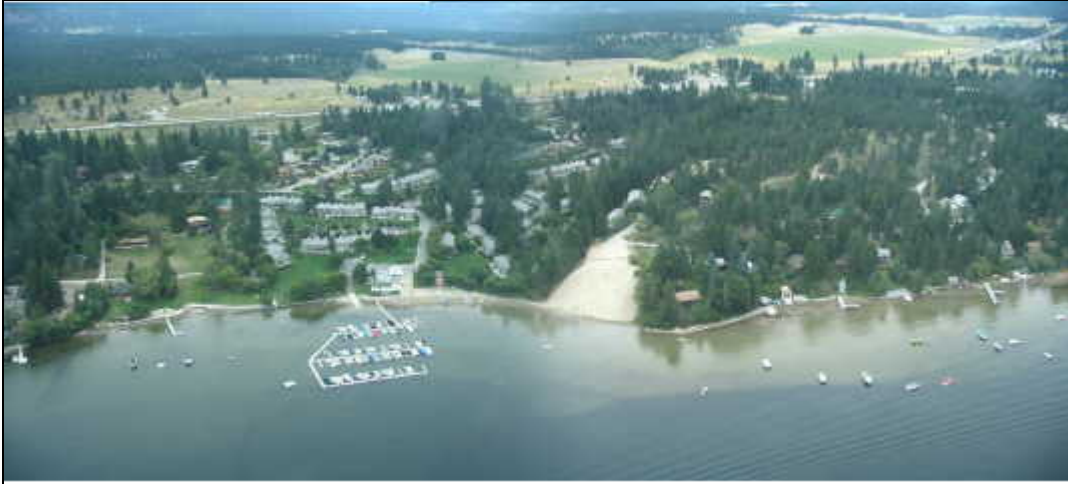
The land use of Segment 24 is composed of approximately half residential and half private recreational (50%) properties. The recreational developments include strata type complexes, such as Terra Vista, Calberley and Akiskinook resorts. These resorts are officially zoned as multi-family residential (R-3; RDEK 2007b). However, for the purposes of this review, they are described as being recreational in nature, because of their private recreational foreshore facilities such as marinas and beach access. The land uses have contributed to disturbance along most of the foreshore (95%). This Segment is mainly vegetated shore type (65%), and there is also some sand beach (20%), cliff/bluff (10%) and wetland (5%) shore types here. The riparian area

is a mixed mature forest that provides abundant cover. Riparian veteran trees are evident (≥ 5). A total of 46 retaining walls (of mixed materials), 17 wooden docks, 1 stonework groyne, 2 marinas, and 13 boathouse structures are evident along this section of shoreline. The first evidence along the eastern shore of undisturbed shoreline and intact upland forested habitat was encountered in this Segment (coming from the north).

Figure 18. Half of Segment 24 has private recreational type developments along the foreshore such as that at Terra Vista Resort and Marina and Calberley Beach (both near the centre of the photo).

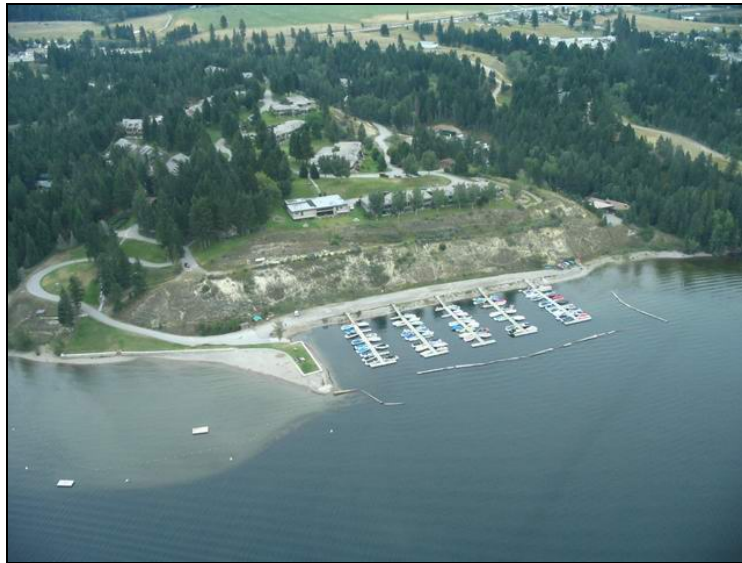
Figure 19. Segment 24 Akiskinook Resort and Marina (private), located near the south end of Segment 24, has contributed to disturbance along a large upland portion of the shoreline.

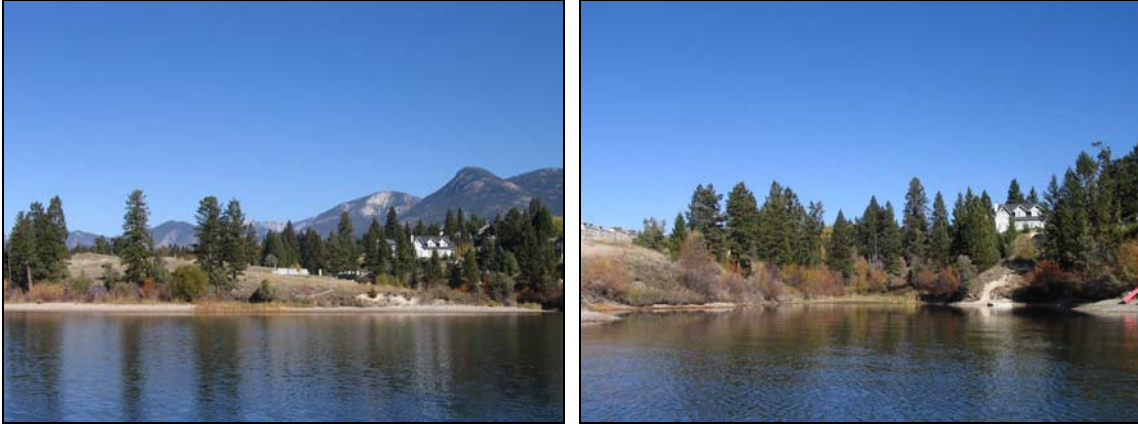
- very good natural shoreline vegetation on the point below the cemetery;
- important isolated wetland below the cemetery and at the head of the bay;
- largest natural protected bay (Hidden Bay) on eastern shore of Windermere Lake provides an important area for waterfowl refuge;
- natural plant communities in the undeveloped areas; and
- topography provides protection.

Figure 20. Segment 25 is all park and provides one of the most important habitats on the north eastern shore of Windermere Lake. The left photo shows the cemetery and the right photo shows the isolated wetland below the cemetery (photos provided by Wildsight).
