**Windermere Lake
Foreshore Inventory and Mapping**

**Prepared for:
East Kootenay Integrated Lake Management
Partnership**

**Final Report
June 2007**

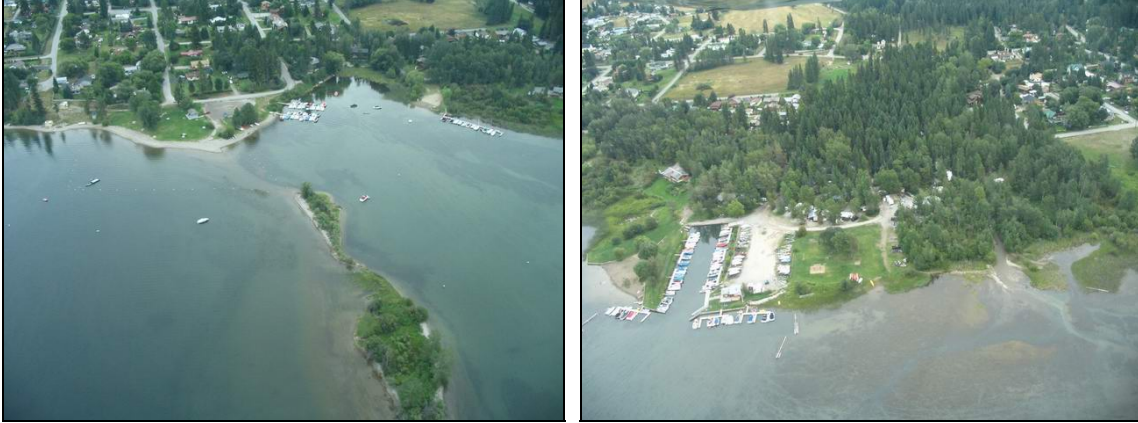
Several structures have been constructed along the foreshore including 24 retaining walls (of mixed materials), 31 wood docks, 6 stonework groynes, 4 marinas, and 8 boathouses. One non-conforming boat house structure located above the outlet of Jane Creek was identified during the field review. This structure is believed to create a barrier to fish movement upstream (Figure 33). The photos provided (Figures 32- 34) progress along the shoreline of Segment 26 in a southerly direction. The riparian habitat at the outlet of Windermere Creek is considered to be important.

Figure 21. Segment 26 - Windermere public beach and the private Cardiff Cove Marina (left); right hand photo shows Shadybrook Marina (private) and valuable riparian / foreshore habitat at outlet of Windermere Creek.

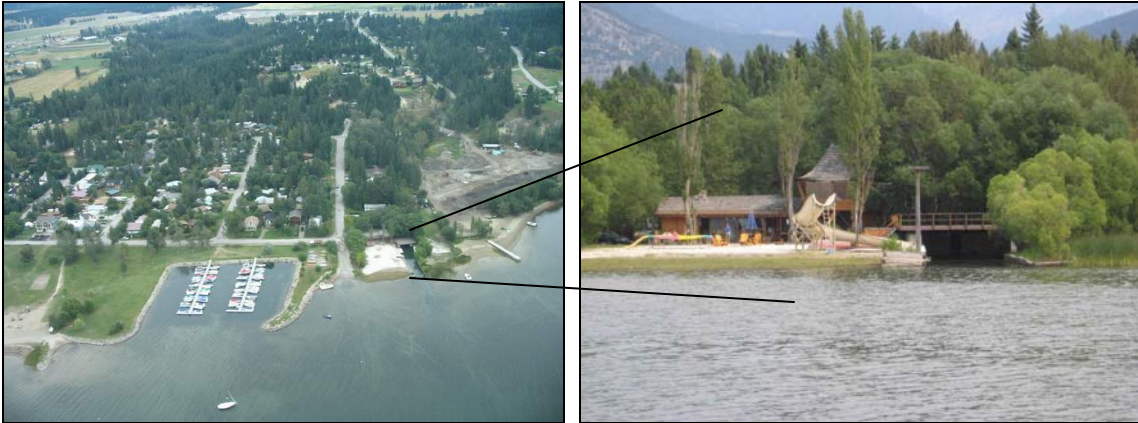
Figure 22. Segment 26 – Left photo shows Trethaway Beach Marina (private), and what was previously Coldstream campground; the right hand photo depicts a closer view of a boat house which is believed to inhibit fish access up Jane Creek.

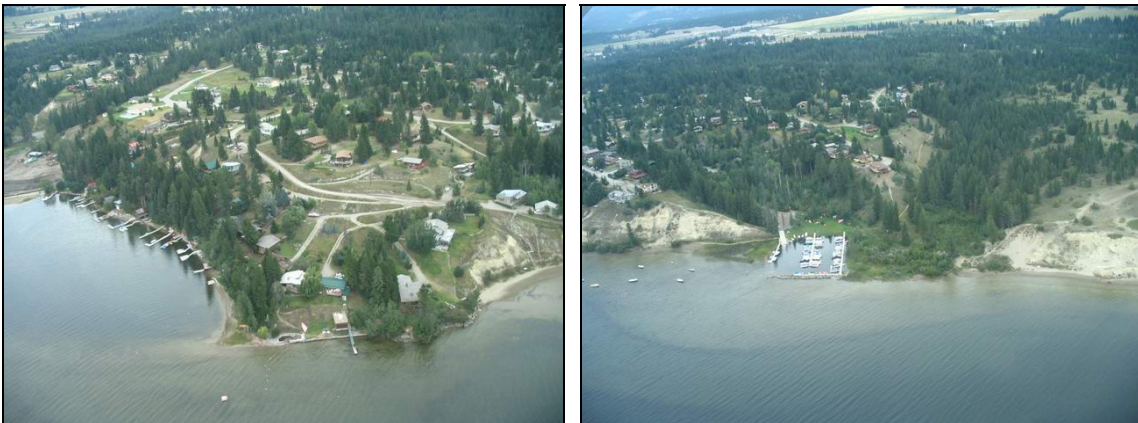
Figure 23. Southern end of Segment 26 has Indian Beach Resort and Indian Beach Marina (private).
