Wasa Lake Foreshore Inventory and Mapping

Prepared for:
Wasa Lake Land Improvement District

Interior Reforestation Co. Ltd.

Final Report
February 2009

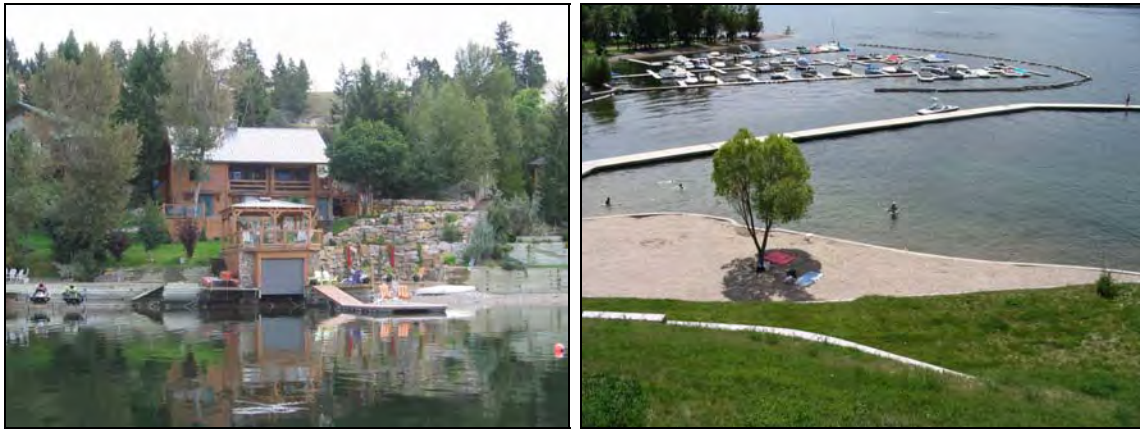
Figure 3. Examples of foreshore modifications including boathouse, dock, retaining wall (left); and marina, dock and retaining wall (right, [photo of Windermere Lake provided by Wildsight]).

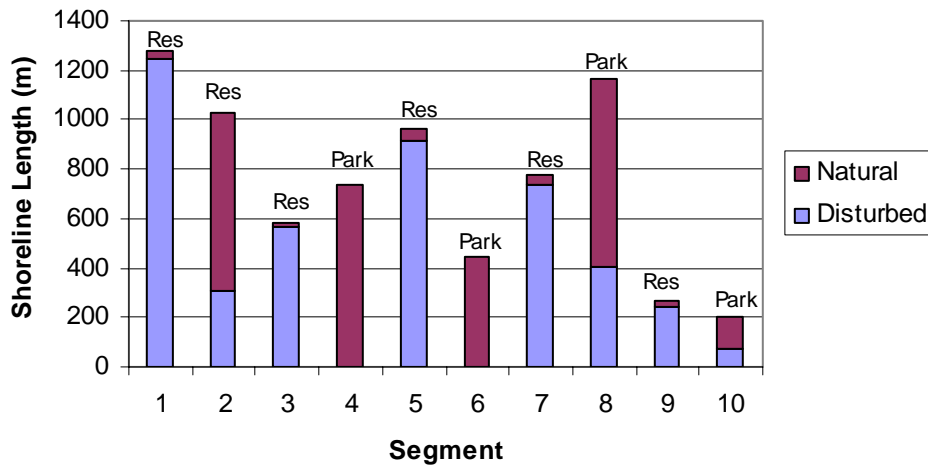
Figure 7. Extent (m) of natural and disturbed shoreline and associated land use (Res. = Residential, Park = Provincial Park) for each segment.

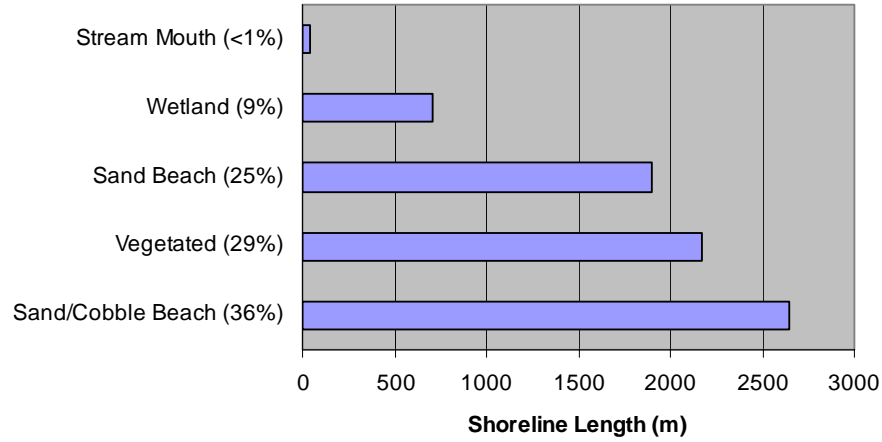
Figure 8. Total length (m) and percentage (%) of each Shore Type along Wasa Lake.

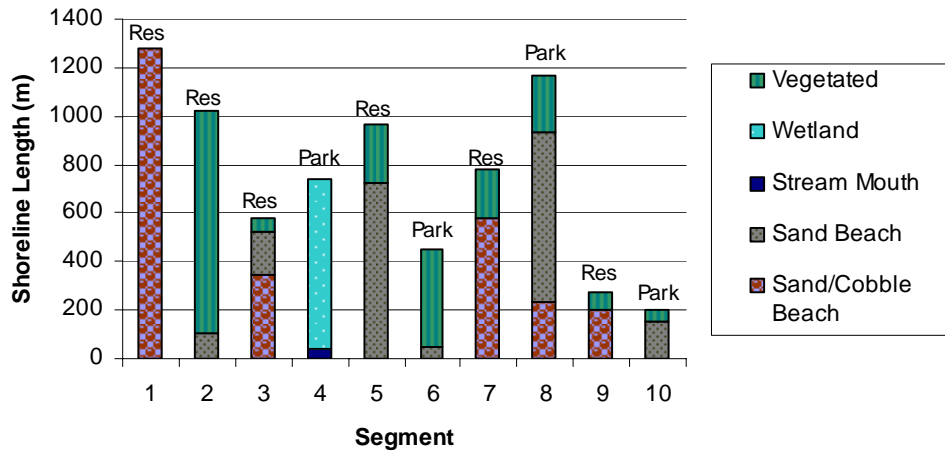
Figure 9. Shore Type and extent (m) for each segment along the foreshore of Wasa Lake.

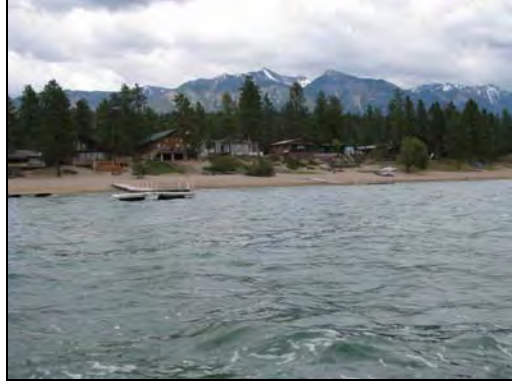
- ◆ The Sand/Cobble Beach Shore Type was not evident during high water levels, but at low water levels appeared prevalent in many segments around the lake (Figure 10). This was considered an important shore type to distinguish, particularly because many, but not all, of the areas where the Sand Beach Shore Type were found, were anticipated to likely have been the result of extensive beach grooming (sand placement) primarily for recreational purposes. The placement of sand appeared in both park and residential segments and will be discussed in the following section.

Figure 10. Segment 1, showing extensive sandy beach at high water, however, this area was extensively covered with cobble substrate at lower water levels.

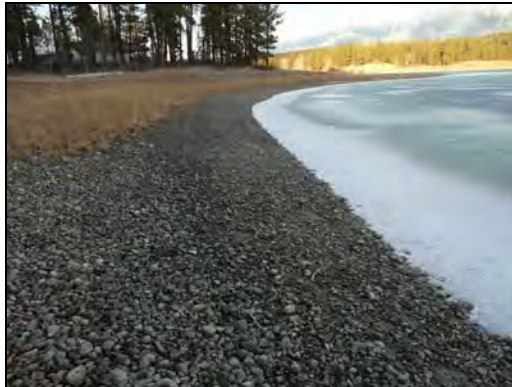
- ◆ Although Segment 6 was classified as a Vegetated Shore Type, substantial sections of cobble were identified along the shoreline at low water levels, and at high water levels (as evidenced through the orthophotos) (Figure 11). In this location, there were two overlapping shore types and it was decided that the intact vegetation along the shoreline was the significant feature for classification.

Figure 11. Cobble shoreline following the base of the Vegetated shore type of Segment 6.

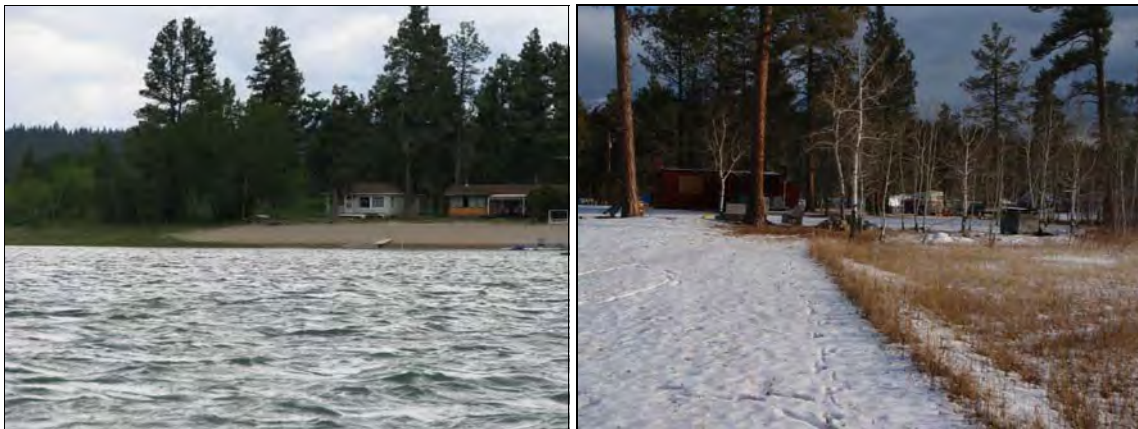
Considering all segments, 36% of the total foreshore length was estimated to have been beach groomed. Substantial beach grooming (>50%) has occurred in the residential Segments 1, 3, 5 and 7, and the park-Segment 10. Figure 14 provides beach grooming examples from sites in Segments 1 and 5. The photos clearly depict the “grooming line”, showing the contrast of the sandy or unvegetated beaches up against the vegetative features of the neighbouring shoreline, which in the case of the left photo is a park in a natural state (Segment 4). Maintaining a natural vegetative cover is preferable, and this has been done in some cases, while allowing for recreational use of the beach (Figure 15). In this photo, the dock has been placed at the low water mark and the vegetation and substrates higher on the shoreline were left intact.

Figure 14. Examples of beach grooming: vegetation has been removed and sand has been placed along the shoreline of Segment 5 (left), and vegetation has simply been mowed in Segment 1 (right),

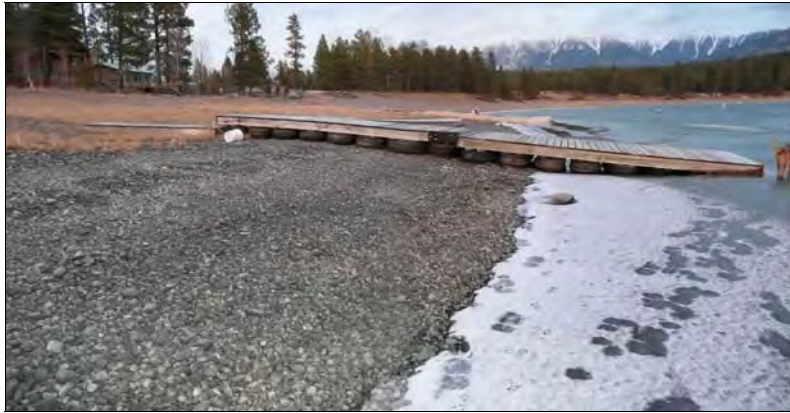
Figure 15. Example of dock attached to the shore at the low water mark where beach grooming was not evident in Segment 7.

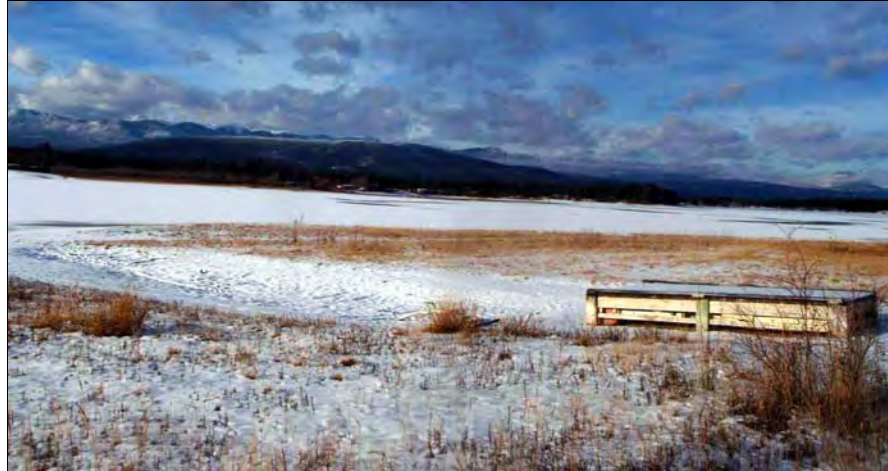
Although, not part of the database, dredging was another modification observed at a few locations around the lake (Segments 1 and 3). Figure 17 depicts a location on Segment 1, which has been dredged in order to allow access up from the shoreline to a dock. This dredging, consequently, appears to have occurred on Crown Land zoned as P-2 Parks and Open Space (RDEK 2002).

Figure 17. Example of area that was dredged in order to allow access to a dock in Segment 1.

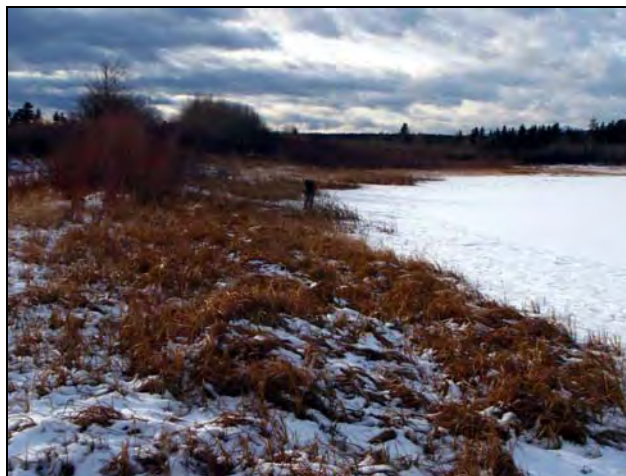
Figure 18. Isolated location of bulrush and cattail evident along Segment 4

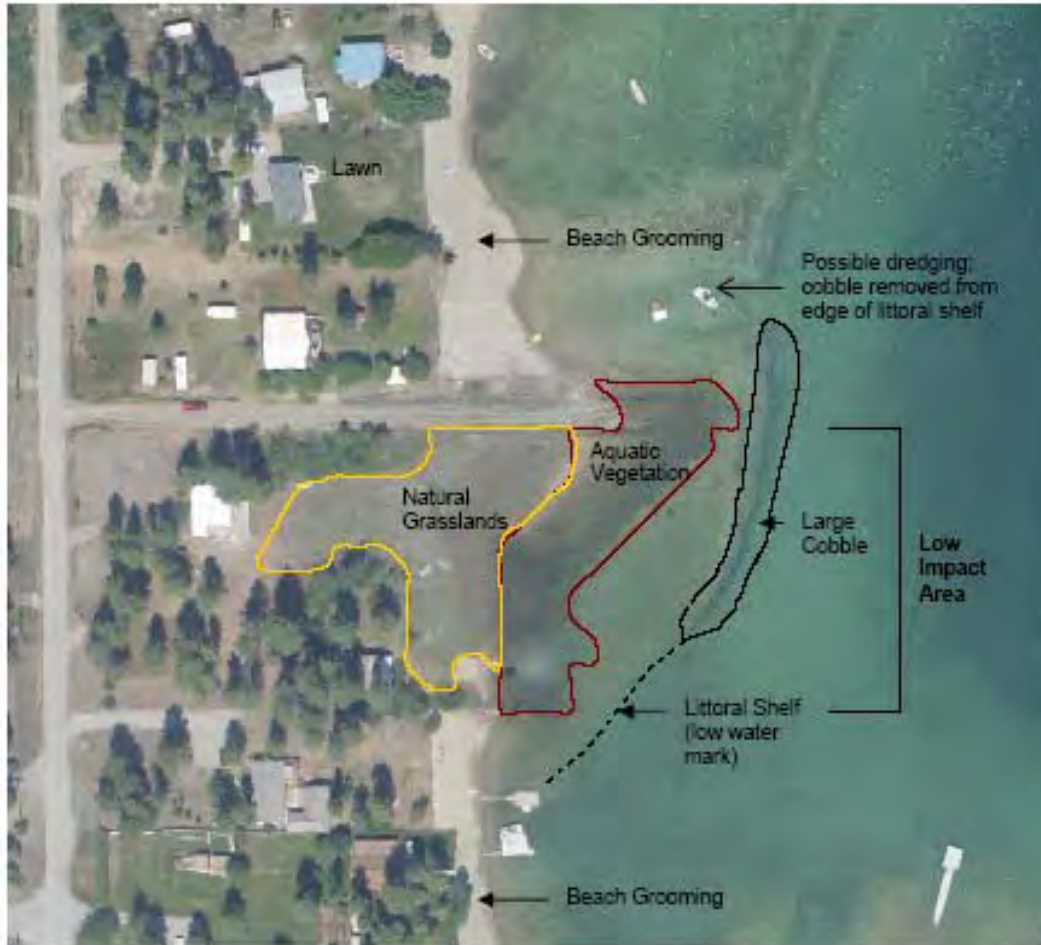
Modifications appear to be converting the physical nature of the lake to sand beach from more diverse shore types such as vegetated and sand/cobble. Figure 20 provides an overview of properties along a part of Segment 3, which exemplify how modifications such as landscaping and beach grooming appear to have impacted the natural shoreline. In this photo, the properties on the north and south ends are evidenced to have been landscaped, beach groomed and have had other modifications (i.e., docks and possible dredging). On these properties, many of the natural features are no longer visible. The central property, however, showed minimal impacts on the shoreline, since it was setback and had limited modifications. As a result, the central property showed extensive area with riparian vegetation (grassland) and aquatic vegetation and cobble substrate in the littoral area. The sand placement on the beach (beach grooming) of the outlying properties appeared to result in loss of natural vegetative and structural features, which are important for biodiversity, aesthetics and water quality. It is important to note that in some locations, (e.g., Segment 6 which is unmodified) some features such as aquatic vegetation, do not exist naturally, as a result of shoreline morphology. An orthophoto review of features for neighbouring, unimpacted properties tends to identify what the natural conditions of a segment once were. This assessment was qualitative, and a thorough quantitative analysis of these relationships was not completed under this project.

Figure 20. Overview of properties along Segment 3, showing area where the natural shoreline features were kept intact (low impact area) against adjacent properties where development has substantially altered the shoreline.

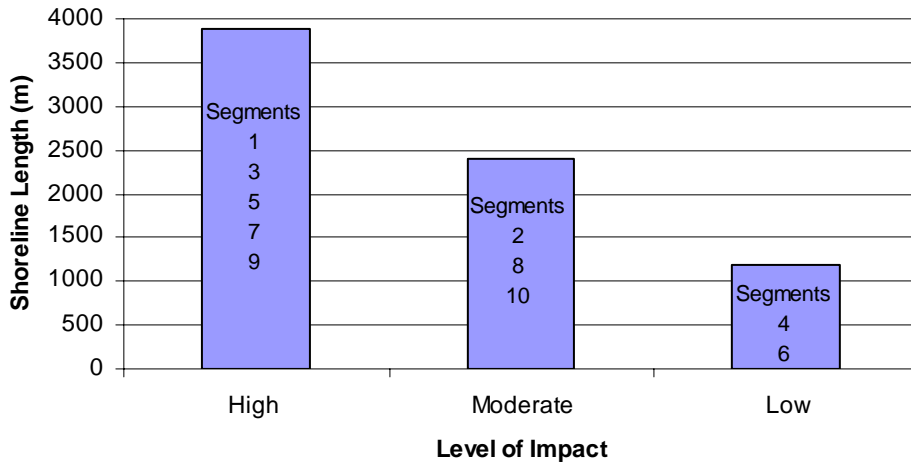
Figure 21. Segment level of impact (LoI) rating (High = >40%, Moderate = 10-40% and Low = <10%) and total shoreline length (m) attributed to each of the LOI ratings.

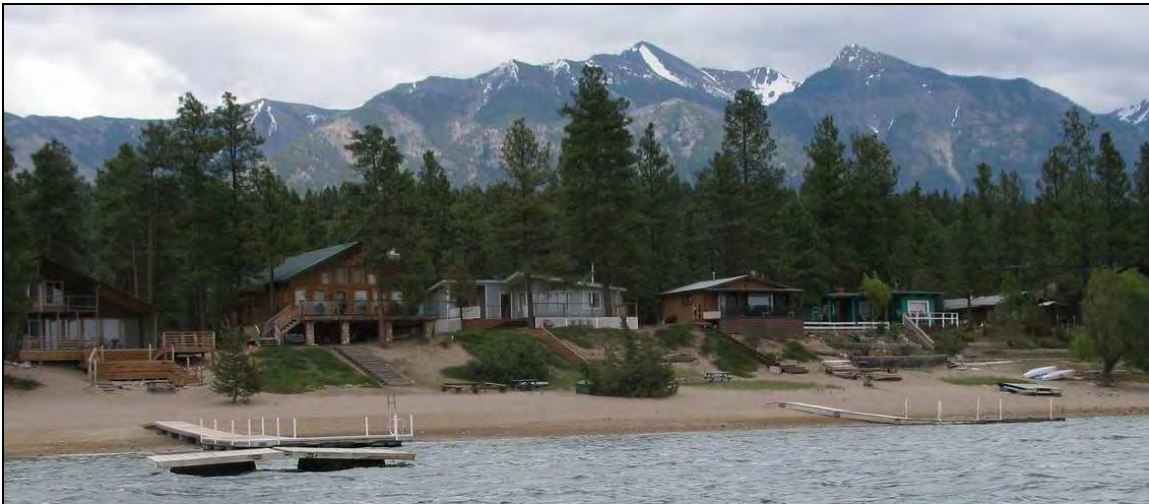
Figure 22. High Level of Impact example (Segment 1), showing how development has impacted most of the shoreline.

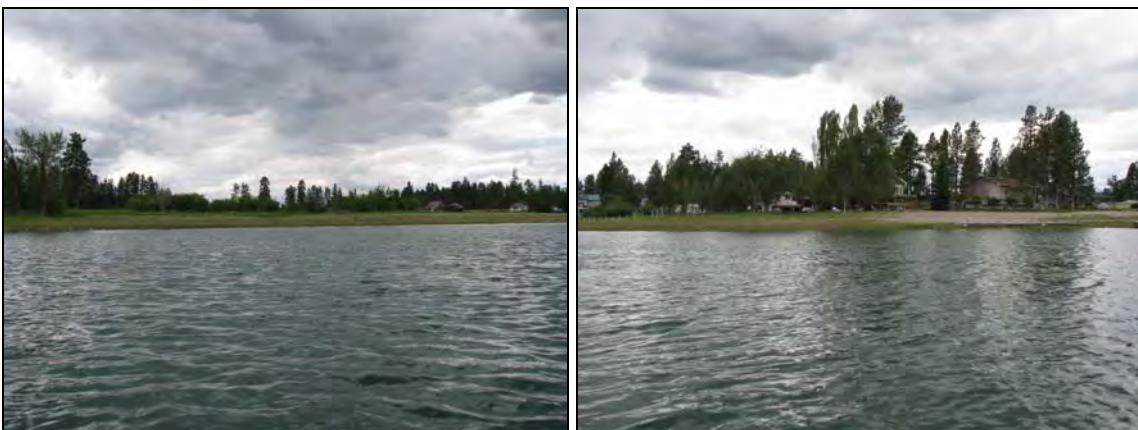
Figure 23. Moderate Level of Impact example (Segment 2), showing how development has impacted approximately 30% of the shoreline.

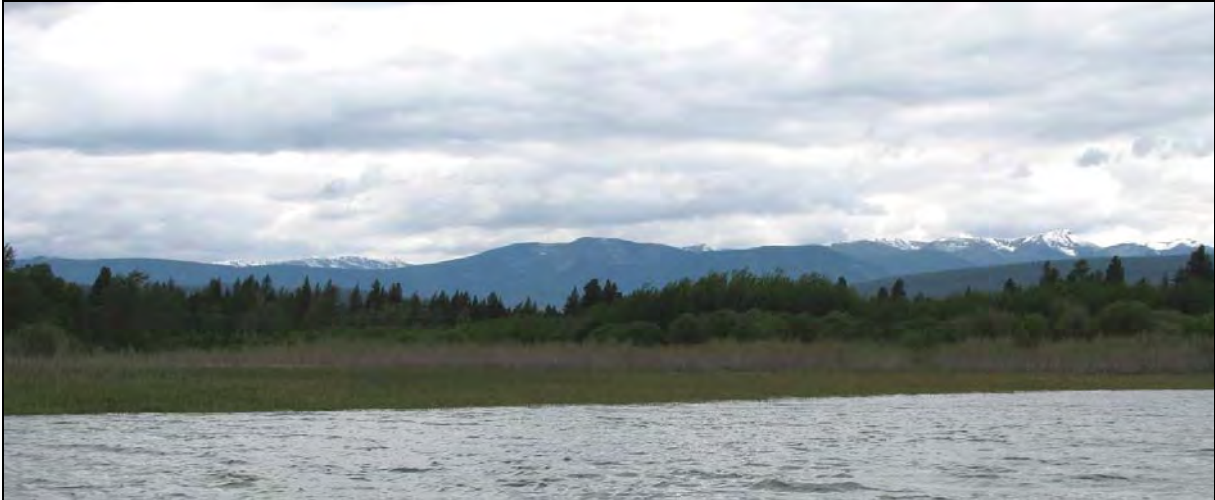
Figure 24. Low Level of Impact example (Segment 4), where the wetland shoreline features are undisturbed and protected as a Provincial Park.

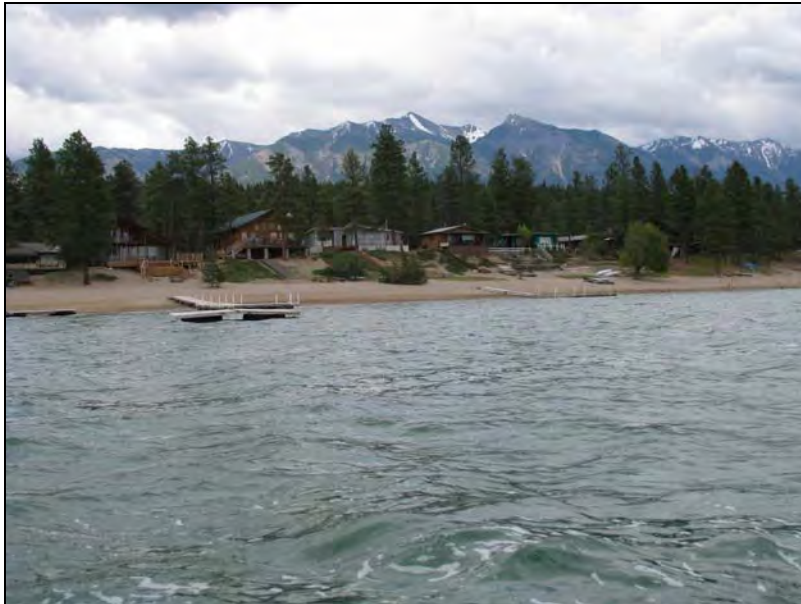
Segment 1 showing sand beach evident at high water levels and residential development.
Photo: Holmes, June 2008.

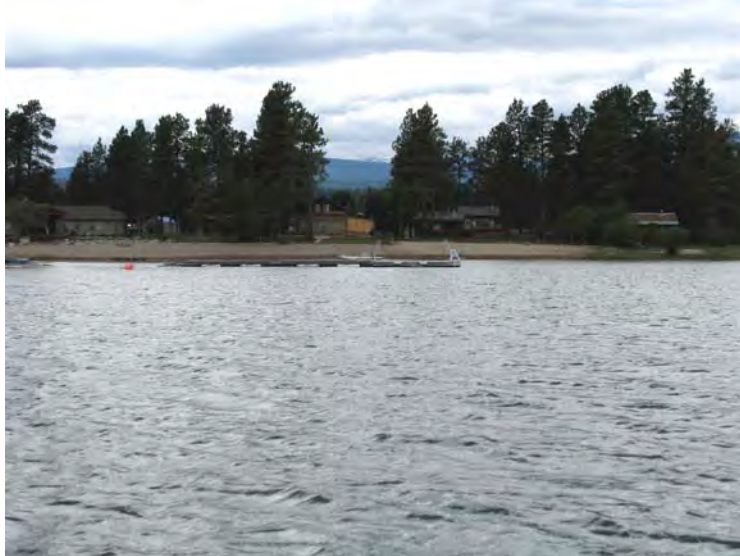
Segment 3 showing extensive sand placement along the shoreline and coniferous trees in the upland area.

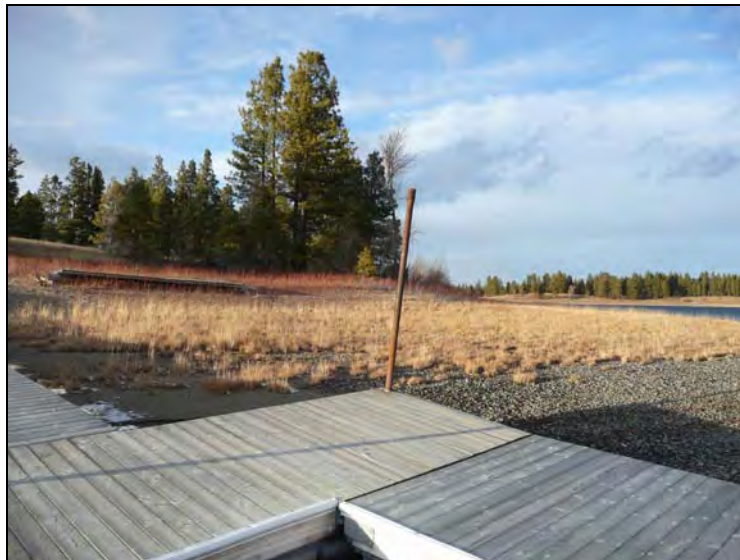
Segment 5 shoreline area that has been left relatively intact, exhibited by emergent vegetation and cobble substrates below high water mark, along with grassland/coniferous mix of vegetation in riparian area. Photo: McPherson, Dec 2008.

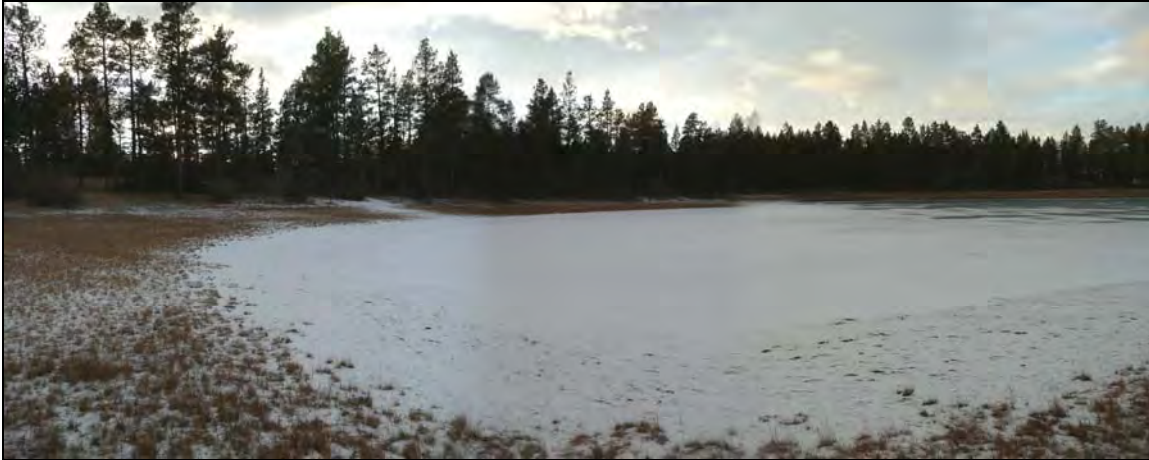
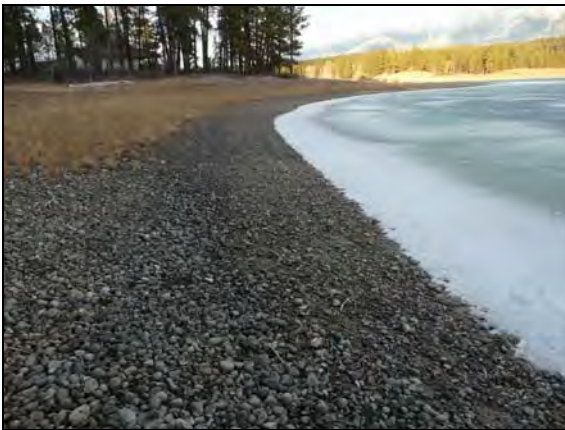
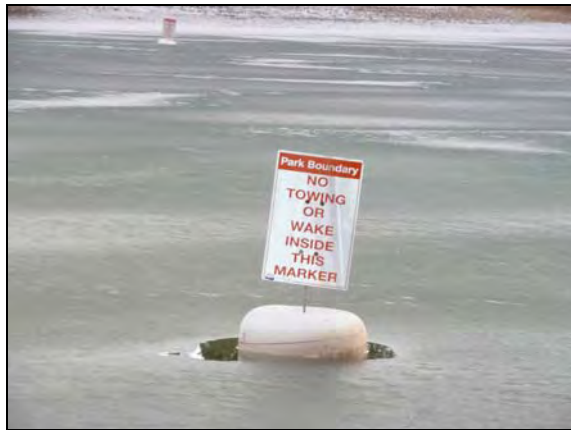
Segment 6 foreshore area showing grasses along the riparian area followed by conifers in the upland (top), cobble substrates along southern stretch (bottom left) and park signage protecting habitat (bottom right). Photo: McPherson, Dec. 2008.

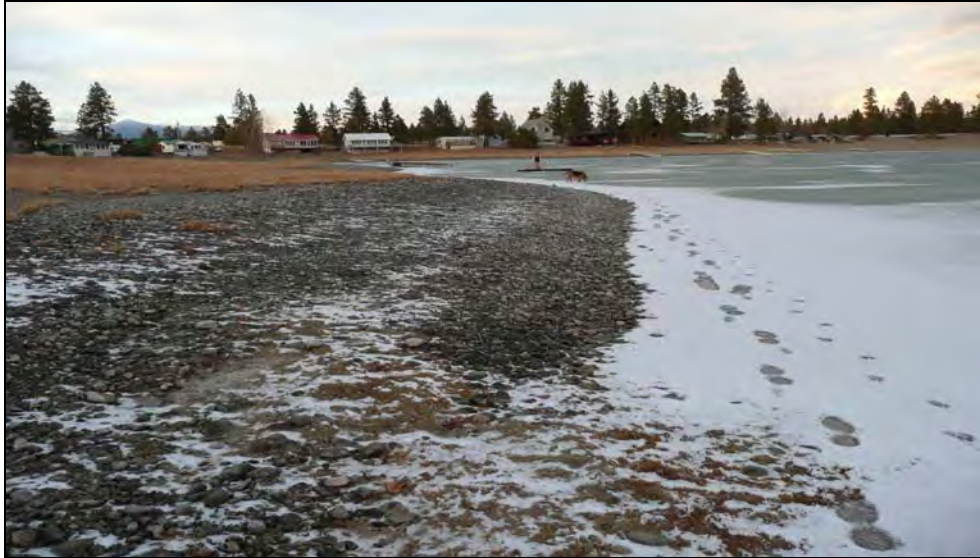
Segment 7, showing cobble substrates evident at low water levels and area where grasses have been maintained to the high water level. Photo: McPherson Dec. 2008.

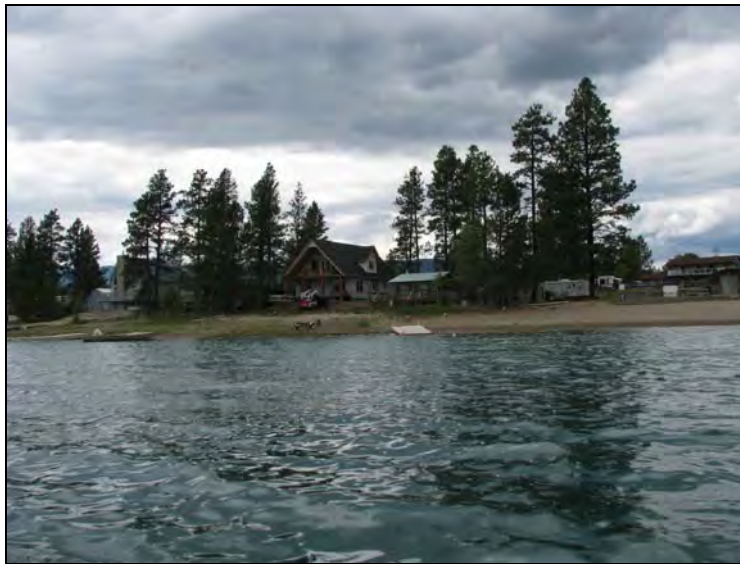
Segment 7, showing property on left where some vegetation along the shore has been left intact and property on the right where beach grooming and retaining wall modifications have greatly altered the natural shoreline. Photo: Holmes, June 2008.

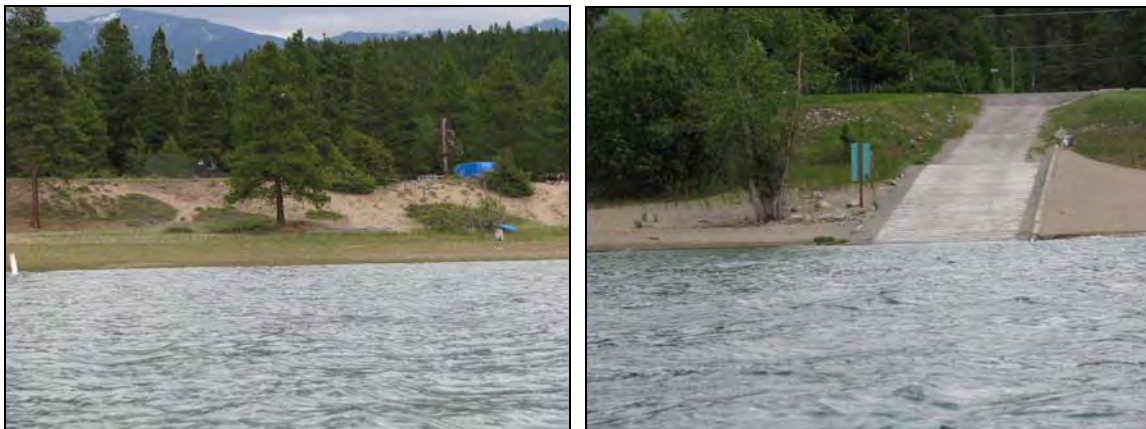
Segment 9: An example location where grass/herb vegetation has been maintained along the shoreline and of houses situated up on a bench (left) and boat launch/groyne structure at end of the segment (right). Photo: Holmes, June 2008.
